**Title: Building Re-Tuning Updated Case Studies**

**Report Date: April 30, 2016**

# Re-tuning Case Study

GSA National Capital Region Re-tunes Office Building and Courthouse. Washington, D.C.

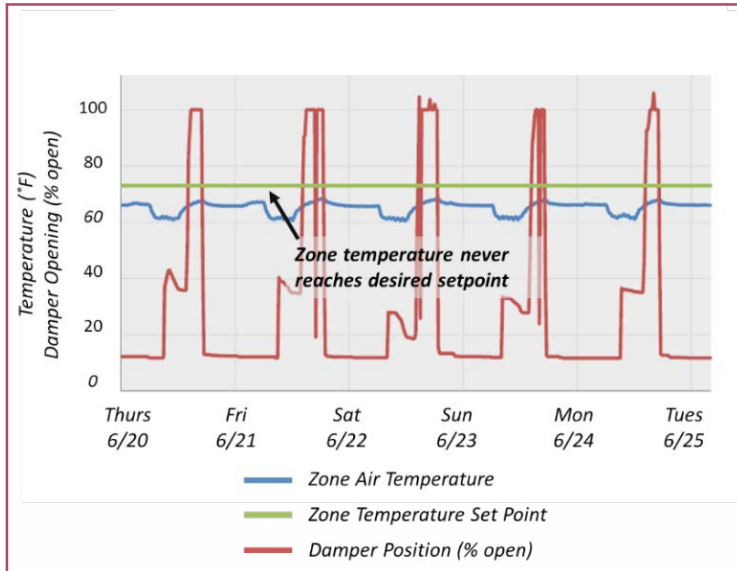
Figure 2 shows the actual zone air temperature (blue line) for one of the zones in the TSRB building, compared to the zone's temperature set point (green line), and its damper position. The fact that the average temperature is consistently below the set point indicates that the zone is overcooled. A significant number of zones were observed to be at minimum temperature and damper position, confirming that many spaces were overcooled. Upon further analysis, the building staff determined that the cause was attributable to the zone's minimum CFM (cubic feet per minute) value being too high. This led the building to institute a re-tuning measure for CFM minimum reset, which led to energy savings as well as increased occupant comfort.

Figure 2. Trended Graph of Zone Temperature and Damper Position Reveals an Overcooled Zone.

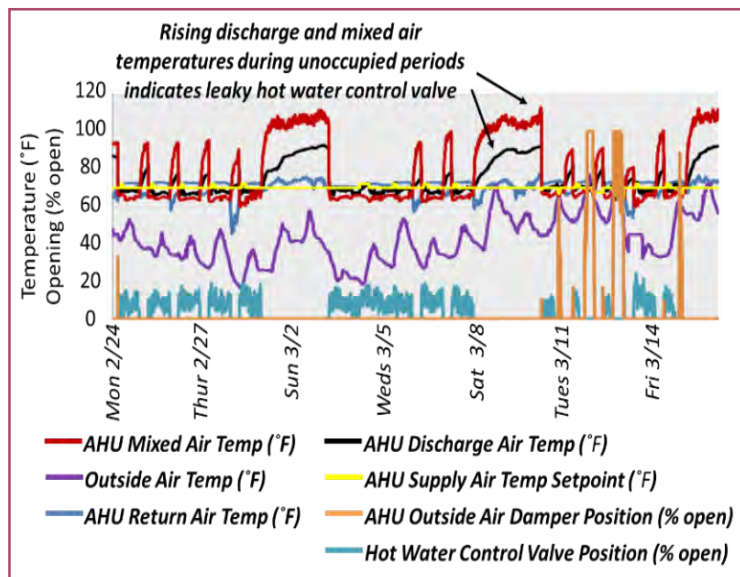
Overnight “baking” was found in the LBJ Building, in which building temperatures rose during cold winter evenings and the HVAC system needed to cool the building during startup the next morning. Building engineers can seal the leaky hot water control valve to temper this inefficient energy operation.

Figure 2 is the BAS trend data chart for the LBJ Building’s AHU-1 system. The discharge air (black line) and mixed air (red line) temperatures on the AHU-1 rise from 90°F to almost 110°F during unoccupied periods. Valve is leaking, because the hot water control valve’s signal (teal line) is indicating 0% open during the same time period in the charts.

Figure 2. BAS trend data shows AHU-1 discharge air and mixed air temperature data

Engineers remedied this situation on the spot by increasing the output signal to the valve from 8 psi to 12 psi, which closed it completely.

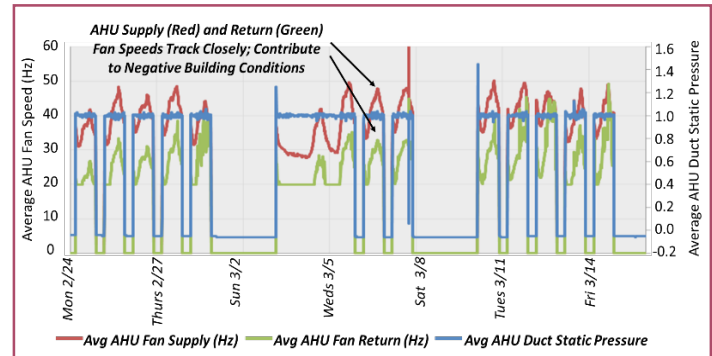
Generally, return fans are able to move significant amounts of air, even with smaller motors and slower fan speeds as a result of the much lower static pressure drops (no filters, no coils, and no ductwork) that these return fans are moving air through. If not controlled properly, they can contribute to negative building conditions.

Figure 4. BAS trend data from LBJ AHU-1 system show supply static pressure and fan speed data

- Consider implementing a reset of the static pressure set point (adjust between 0.5 inches to up 1.0 inches.)
- Consider installing a sensor that monitors the building static pressure (referenced to outside). With a reliable and properly located building static pressure sensor, the return fan speed control can be better managed to prevent over-speed operations that result in negative pressure building conditions.

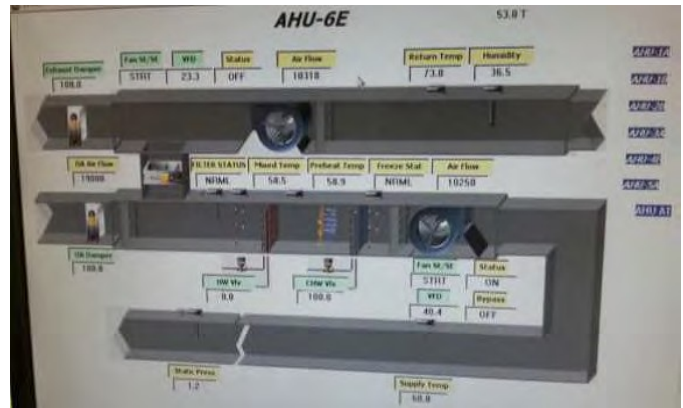
The BAS controls for AHU-6E, shown in Figure 6, indicate that the outdoor air temperature is 53°F while the mixed and preheat temperatures are indicating between 58.5°F and 58.9°F. The return air temperature indicates 73.8°F. The

Figure 6. AHU economizer damper commands and temperature sensor data

Determine if economizers are working properly. Evaluations should include review of control code as well as mechanical linkage and actuators. The AHU in the BAS graphic appears to be leaking air from the return section, into the mixed air section, resulting in warmer discharge air temperatures.

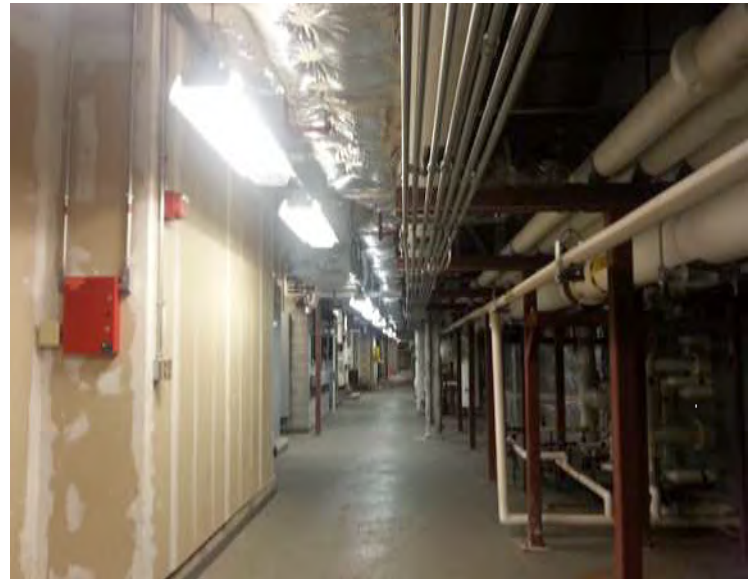
Building walk-throughs help identify efficiency opportunities such as over-lighting in mechanical spaces and garage areas. Figure 8 shows an over-lit mechanical room in the Annex.

*Figure 7. During the Annex Re-tuning building walk-through, operators found lighting in this mechanical room always on*

Parking garages often have a significant number of metal-halide fixtures that are on 24/7. Building operators can implement parking garage lighting upgrades with occupancy controls and LEDs to increase efficiency. Mechanical rooms also offer an opportunity for reduced lighting system usage via manual shut-down or occupancy sensors. Sometimes hundreds of light fixtures may be optimized by increasing the amount of time they are turned off. Operators installed ~40 motion sensors in Annex mechanical and electrical areas.

Operators can also make improvements by de-lamping. Reductions can be confirmed by conducting light level measurements or by removing every other light fixture and running a test to determine if adequate light levels still exist. Removing every other fixture reduces energy use by 50% and creates spare lamps and fixtures for future lighting operations.

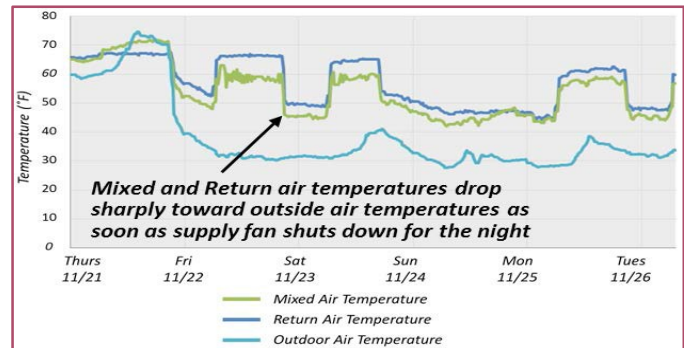
In Figure 2, the mixed air temperature (green line) and return air temperature (blue line) trended data readings both show patterns that may indicate the building is operating in a negative pressure condition at night (and perhaps even during the day). After the supply fan shuts down, both the mixed air and the return air temperature sensors immediately drop toward the outdoor air temperature value (teal line), in some cases dropping as low as almost 40 F. It appears that during the 6-day period in November, the return air temperatures progressively got cooler (possibly indicating that this building also got cooler). Perhaps the reheat system is not working properly, or some other issue exists such as

significant infiltration. There is a re-tuning efficiency opportunity to explore further and solve the root of the problem.

Figure 2. Trended Data Showing Return Air and Mixed Air Temperature Performance

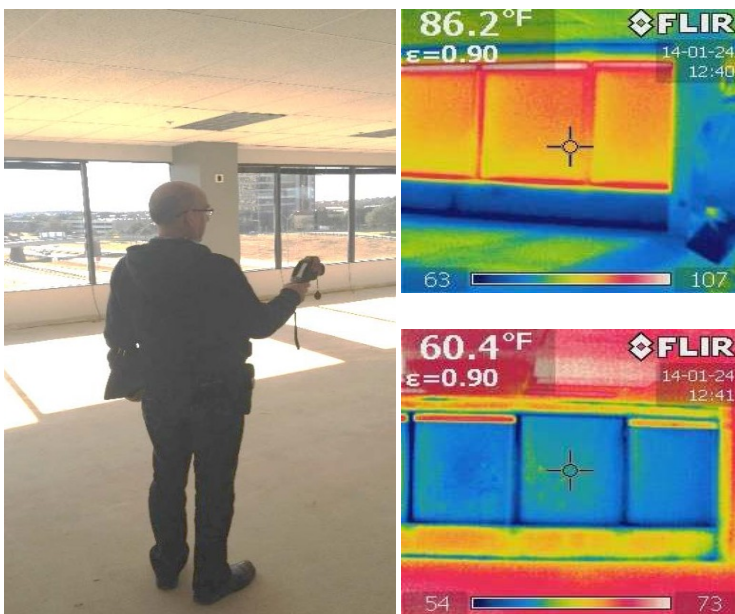
The window-to-wall ratio is significant (at least 80% or greater) in Las Colinas Tower II, meaning that solar loading significantly impacts the building. Using a thermal imaging camera (see Figure 3), a significant difference in window temperatures on the south and west sides of the building was identified. East, south and west-facing windows exhibit significant solar gains on cold, but clear days (morning low temperatures around 20 F, afternoon high temperatures around 45 F). This was creating interior temperatures between 75 F and 78 F at the perimeter spaces facing south. Re-tuning measures to consider for buildings to counter solar heat gain include:

Figure 3. A thermal imaging camera is used to identify solar load for south-facing (top) and west-facing (bottom) windows

- Send periodic messages to occupants via email to encourage the judicious use of window blinds during peak solar conditions.
- Turn perimeter lights off (where controls and switching allow) to reduce the heat gain from electric lighting loads (trade off the solar gain with the lighting heat gain or vice versa) or de-lamp where possible.
- Window tinting may be an effective investment, but should be carefully evaluated for correct tinting materials and installation methods to safeguard windows from damage

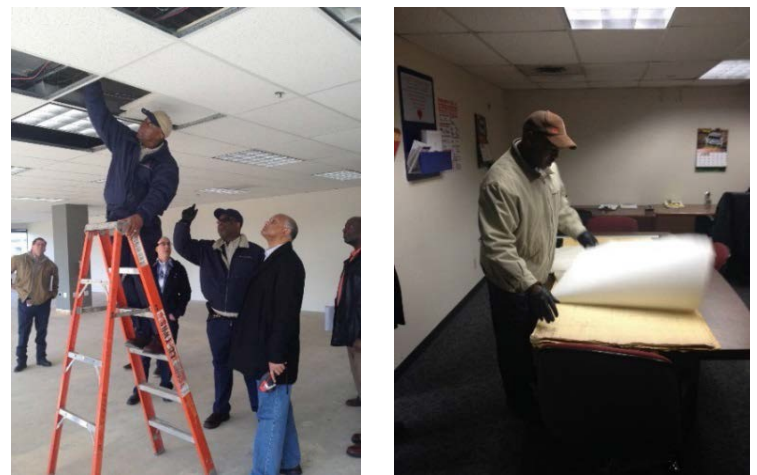
After the re-tuning training, the Las Colinas team decided to walk-down the building after hours. Operators found numerous inefficiencies: heat on after hours, task and break room lighting on while space was unoccupied, and terminal air fans running.

Figure 4. Building walk-down included checking above the ceiling for duct condition, etc. (left) and reviewing electrical and mechanical prints (right)

To solve this, they asked security to turn off all lights left on by tenants, and proposed installing electric to pneumatic (EP) switches on every floor to shut off all non-essential loads after hours.

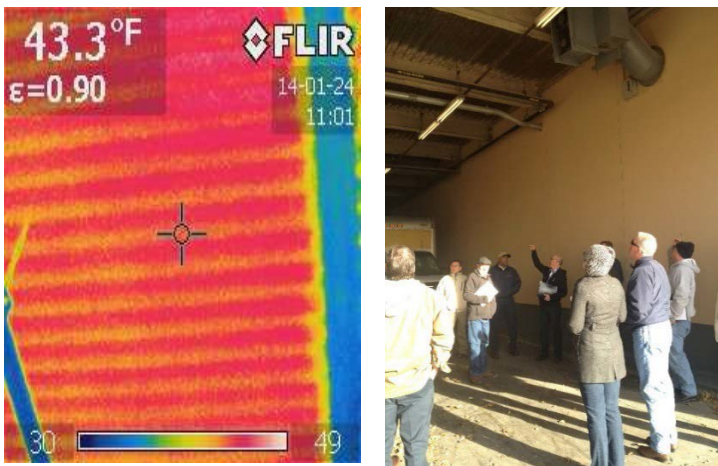
Figure 5 shows an infrared image of the Parmenter Las Colinas II loading dock ceiling, just below office space. The outdoor air temperature is 30 F while the ceiling temperature was measured much higher at 43.3 F. During the re-tuning training building walk-down, it was noted that the loading dock ceiling insulation may be lacking. This likely has resulted in heat loss/gain to the office spaces above, which could contribute to tenant hot/cold calls and energy inefficiencies.

Figure 5. A thermal imaging camera is used to examine the loading dock ceiling

Re-tuning opportunities include evaluating areas of missing insulation or poorly insulated/sealed locations in loading docks, parking garages, and similar areas open to the outdoors.

- Verify that initial garage parking lot area under office spaces is adequately insulated (hard ceiling with access panels). Suggest using an infrared camera image of the floor from above (looking down) if access issues are a problem.
- Seal penetrations of conduits and piping that route from loading dock areas into the building.
- Look for similar penetrations that may not be sealed on all perimeter sides of the building

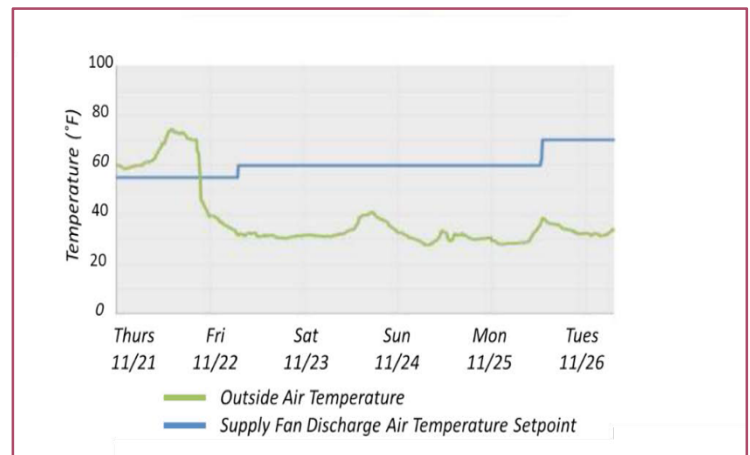
In Figure 6, the AHU discharge air temperature set point (blue line) appears to be manually adjusted, based on the staggered stair-step flat lines. The discharge air temperature set point in the control code was found to be reset automatically from the return air temperature with a secondary reset based upon the outside air temperature. Figure 6 hints at manual overrides being used, so perhaps the automatic reset values are too low.

Figure 6. Manual Override on AHU Supply Fan Discharge Air Temperature Set Point

- Use a return air temperature reset only (remove the secondary outdoor air temperature reset). The current reset operation is currently between 70 F and 74 F return air temperatures, but the reset should be based upon the return air temperature operating between 72 F and 76 F. This schedule will lead to more comfortable conditions and will decrease the need for occupants/tenants to request overrides of the system's schedule
- Reset the discharge air temperature (blue line) to be between 53 F and 63 F, a 5 F increase. The current operation is between 48 F and 58 F. With this increase, the supply air should still be cool enough to provide adequate cooling at the warmest zones and provide adequate moisture removal at the cooling coils. The existing reset parameters result in higher energy costs for cooling and subsequent reheating at the terminal boxes
