Re-tuning Case Study

Parmenter Re-tunes Las Colinas Tower for Significant Energy Savings. Dallas, TX

Energy Star score improves by four points with Building Re-tuning training.

*Address: 225 E. John Carpenter Frwy, Irving TX
Owner: Parmenter Realty Partners
Size: 349,436 square feet*

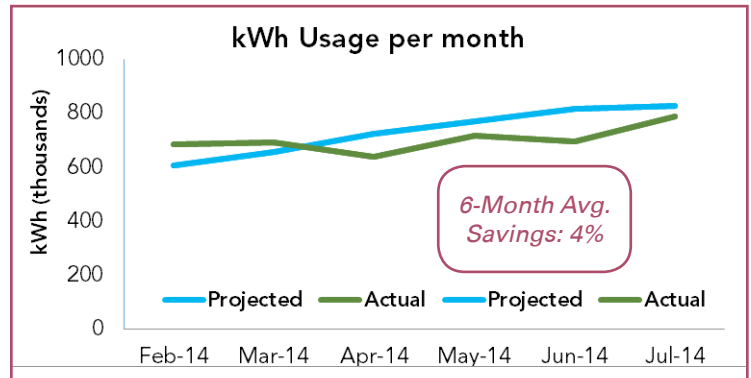
Figure 1. Projected kWh usage based on a year's monthly consumption prior to re-tuning and weather normalization.

In the 6 months post-training, the building has saved an average of 4% on its electricity usage due to a long list of energy savings opportunities (details shown on following pages. See Figure 1). Las Colinas Tower II also improved its ENERGY STAR score by four points from 67 to 71.

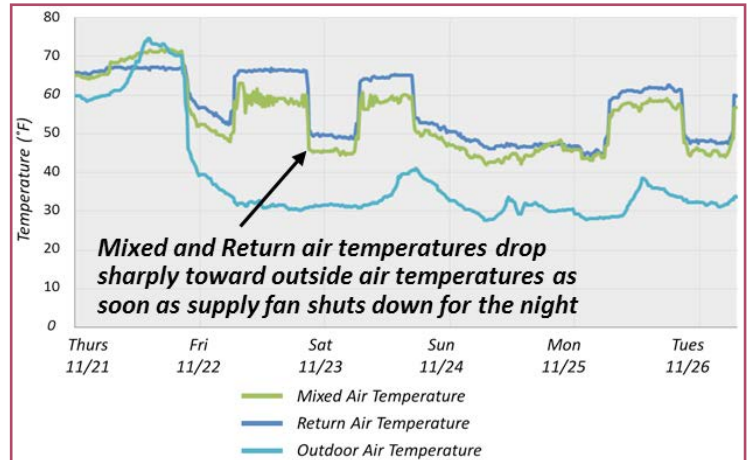
Figure 2. Trended Data Showing Return Air and Mixed Air Temperature Performance

In Figure 2, the mixed air temperature (green line) and return air temperature (blue line) trended data readings both show patterns that may indicate the building is operating in a negative pressure condition at night (and perhaps even during the day). After the supply fan shuts down, both the mixed air and the return air temperature sensors immediately drop toward the outdoor air temperature value (teal line), in some cases dropping as low as almost 40°F. It appears that during the 6-day period in November, the return air temperatures progressively got cooler (possibly indicating that this building also got cooler). Perhaps the reheat system is not working properly, or some other issue exists such as

significant infiltration. There is a re-tuning efficiency opportunity to explore further and solve the root of the problem.

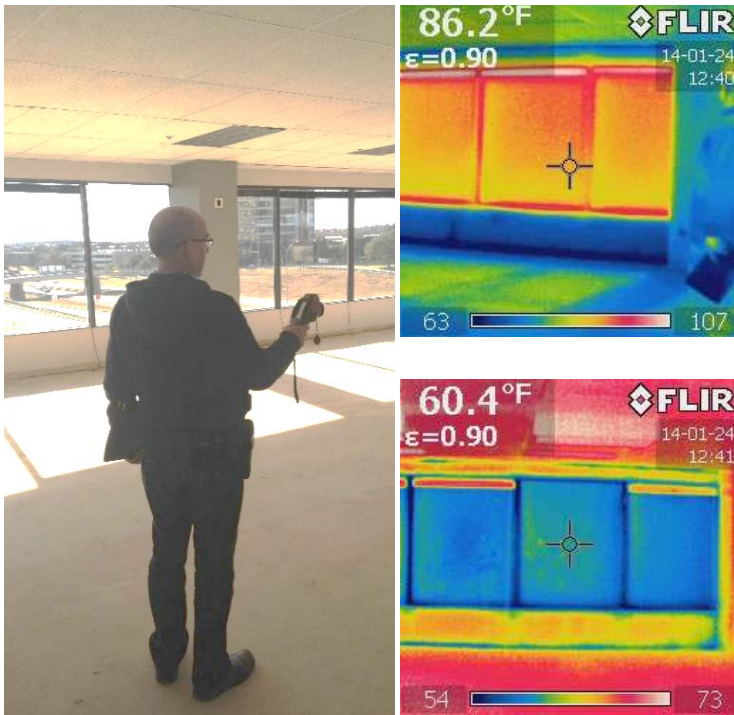
The window-to-wall ratio is significant (at least 80% or greater) in Las Colinas Tower II, meaning that solar loading significantly impacts the building. Using a thermal imaging camera (see Figure 3), a significant difference in window temperatures on the south and west sides of the building was identified. East, south and west-facing windows exhibit significant solar gains on cold, but clear days (morning low temperatures around 20°F, afternoon high temperatures around 45°F). This was creating interior temperatures between 75°F and 78°F at the perimeter spaces facing south. Re-tuning measures to consider for buildings to counter solar heat gain include:

Figure 3. A thermal imaging camera is used to identify solar load for south-facing (top) and west-facing (bottom) windows

- Send periodic messages to occupants via email to encourage the judicious use of window blinds during peak solar conditions.
- Turn perimeter lights off (where controls and switching allow) to reduce the heat gain from electric lighting loads (trade off the solar gain with the lighting heat gain or vice versa) or de-lamp where possible.
- Window tinting may be an effective investment, but should be carefully evaluated for correct tinting materials and installation methods to safeguard windows from damage

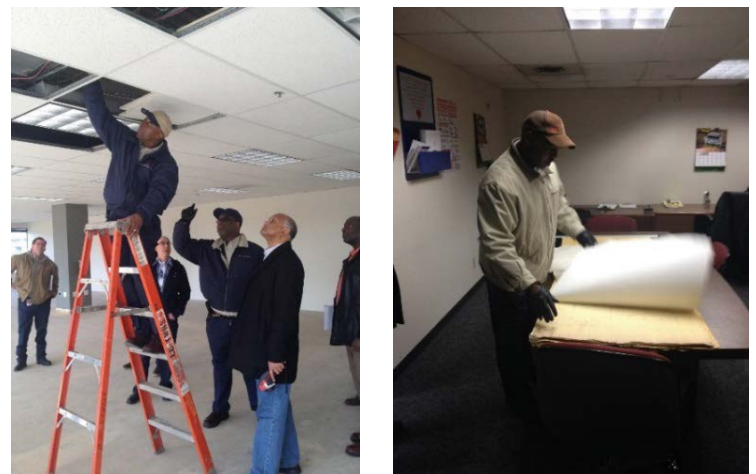
After the re-tuning training, the Las Colinas team decided to walk-down the building after hours. Operators found numerous inefficiencies: heat on after hours, task and break room lighting on while space was unoccupied, and terminal air fans running.

Figure 4. Building walk-down included checking above the ceiling for duct condition, etc. (left) and reviewing electrical and mechanical prints (right)

To solve this, they asked security to turn off all lights left on by tenants, and proposed installing electric to pneumatic (EP) switches on every floor to shut off all non-essential loads after hours.

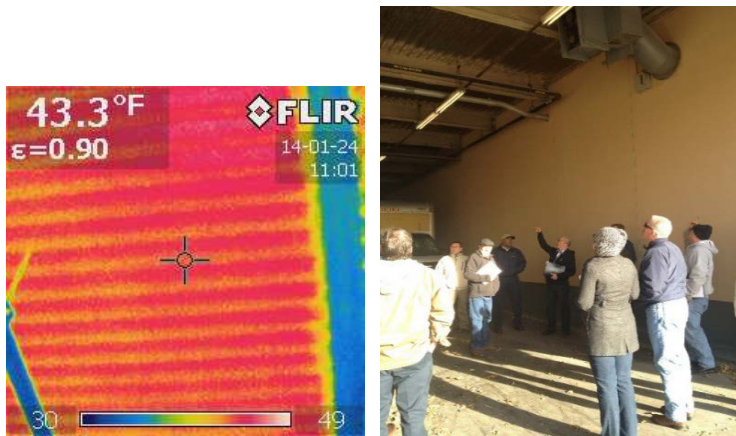
Figure 5 shows an infrared image of the Parmenter Las Colinas II loading dock ceiling, just below office space. The outdoor air temperature is 30°F while the ceiling temperature was measured much higher at 43.3°F. During the re-tuning training building walk-down, it was noted that the loading dock ceiling insulation may be lacking. This likely has resulted in heat loss/gain to the office spaces above, which could contribute to tenant hot/cold calls and energy inefficiencies.

Figure 5. A thermal imaging camera is used to examine the loading dock ceiling

Re-tuning opportunities include evaluating areas of missing insulation or poorly insulated/sealed locations in loading docks, parking garages, and similar areas open to the outdoors.

- Verify that initial garage parking lot area under office spaces is adequately insulated (hard ceiling with access panels). Suggest using an infrared camera image of the floor from above (looking down) if access issues are a problem.
- Seal penetrations of conduits and piping that route from loading dock areas into the building.
- Look for similar penetrations that may not be sealed on all perimeter sides of the building

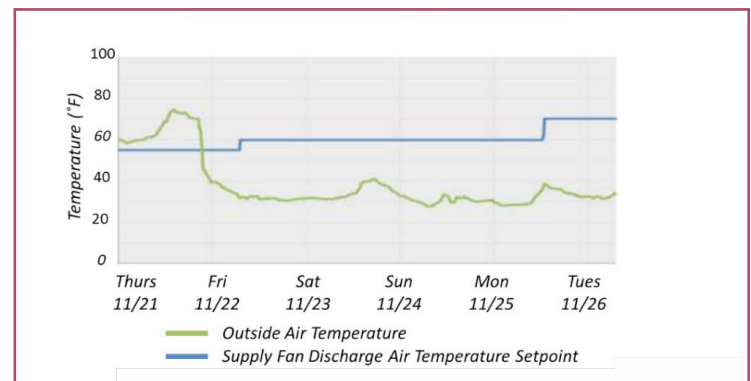
In Figure 6, the AHU discharge air temperature set point (blue line) appears to be manually adjusted, based on the staggered stair-step flat lines. The discharge air temperature set point in the control code was found to be reset automatically from the return air temperature with a secondary reset based upon the outside air temperature. Figure 6 hints at manual overrides being used, so perhaps the automatic reset values are too low.

Figure 6. Manual Override on AHU Supply Fan Discharge Air Temperature Set Point

- Use a return air temperature reset only (remove the secondary outdoor air temperature reset). The current reset operation is currently between 70°F and 74°F return air temperatures, but the reset should be based upon the return air temperature operating between 72°F and 76°F. This schedule will lead to more comfortable conditions and will decrease the need for occupants/tenants to request overrides of the system's schedule.
- Reset the discharge air temperature (blue line) to be between 53°F and 63°F, a 5°F increase. The current operation is between 48°F and 58°F. With this increase, the supply air should still be cool enough to provide adequate cooling at the warmest zones and provide adequate moisture removal at the cooling coils. The existing reset parameters result in higher energy costs for cooling and subsequent reheating at the terminal boxes.
