Re-tuning Case Study

Georgia Tech Re-tunes Research Building and Saves 18.2% on Electricity. Atlanta, GA

*Address: TSRB, 85 Fifth St NW, Atlanta, GA
Owner: The University Financing Foundation
Lease: Georgia Tech, Triple Net Lease
Size: 209,000 Square Feet*

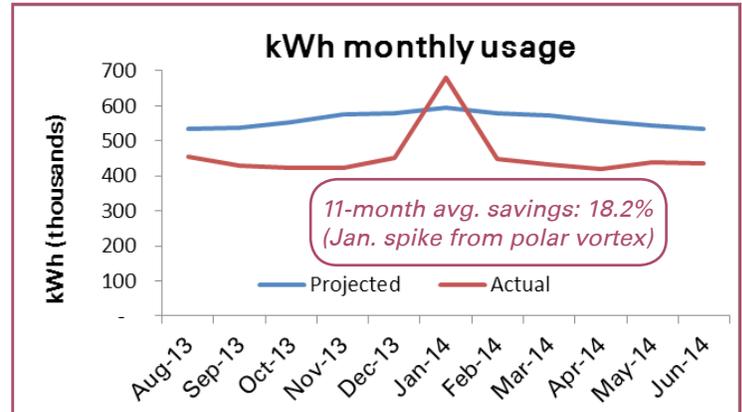
Figure 1. Projected kWh usage based on a year's monthly consumption prior to re-tuning and weather normalized.

improved its energy performance, increasing its ENERGY STAR rating from 35 in 2009 to 67 in 2013. Re-tuning contributed to this improvement and the building's ongoing process of re-tuning should help increase the building's ENERGY STAR score further over time.

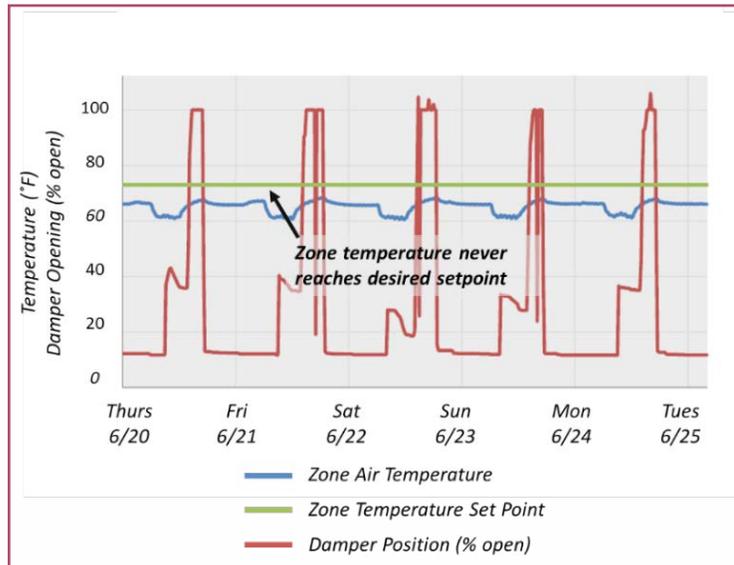
Figure 2. Trended Graph of Zone Temperature and Damper Position Reveals an Overcooled Zone

Figure 2 shows the actual zone air temperature (blue line) for one of the zones in the TSRB building, compared to the zone's temperature set point (green line), and its damper position. The fact that the average temperature is consistently below the set point indicates that the zone is overcooled. A significant number of zones were observed to be at minimum temperature and damper position, confirming that many spaces were overcooled. Upon further analysis, the building staff determined that the cause was attributable to the zone's minimum CFM (cubic feet per minute) value being too high. This led the building to institute a re-tuning measure for CFM minimum reset, which led to energy savings as well as increased occupant comfort.
