Best Practice Recommendations for Wall Retrofit on the Two-Story Flexible Research Platform (FRP) at Oak Ridge National Laboratory (ORNL).

Wall retrofit strategies for retrofit on the interior side of masonry wall construction for existing commercial buildings.

April, 2016

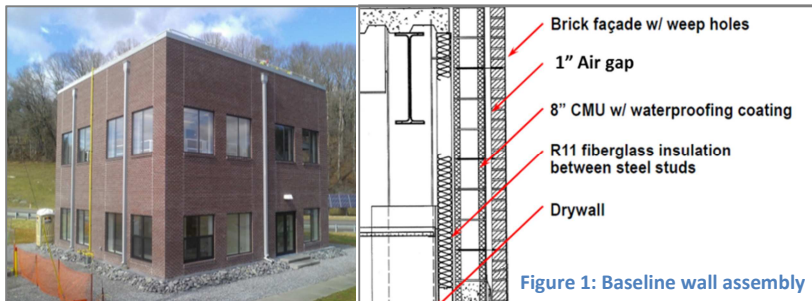
Two-Story Flexible Research Platform at ORNL

The baseline envelope system for the FRP was built to represent the wall systems typical of the majority of the existing commercial buildings built prior to the 1980s located in the 10-county region surrounding Philadelphia (Otto K., 2011^{1**}). This analysis was based on CBECS and COSTAR data.

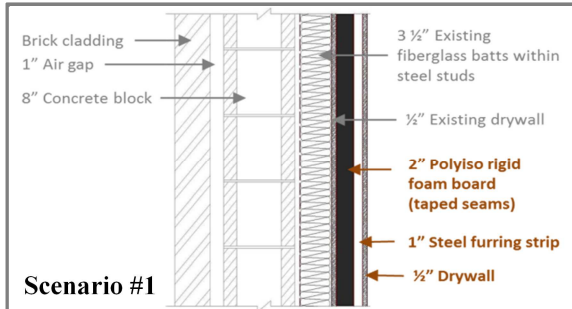
Scenario #1

Figure 2: PIR (polyisocyanurate) foam board installed over existing wall assembly.

- Assembly has existing insulation and
- Existing insulation is in effective condition.

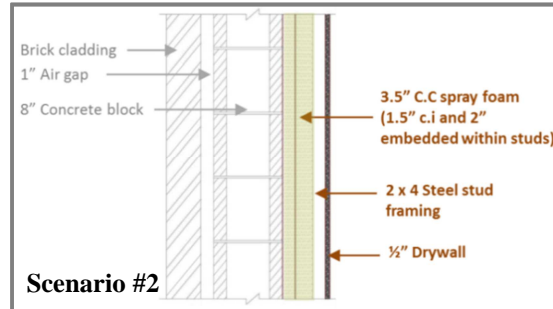
Scenario #2

Figure 3: Closed-cell (C.C) spray foam installed continuous (c.i) over inside face of concrete block

- Assembly has no existing insulation or
- Existing insulation is in poor condition and requires removal.

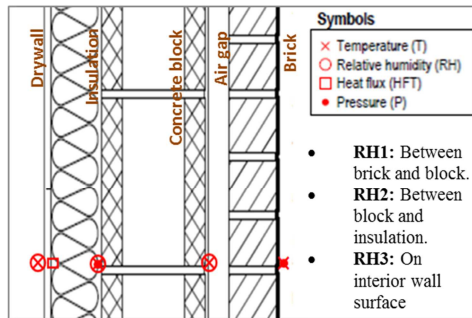
Three types of data were collected for each retrofit; interior and exterior temperatures, heat flux, and moisture performance. The moisture content within the wall assembly was measured using three relative humidity sensors - RH1, RH2 and RH3, and the locations can be found in Figure 4. Both retrofits occupied the North-West zone of the FRP. The spray foam retrofit took place on the first floor (1F), while the PIR retrofit took place on the second floor (2F). Data was analyzed for a random week each month from September to February.

Figure 4: Sensor layout within the baseline exterior wall assembly for the two-story Flexible Research Platform.

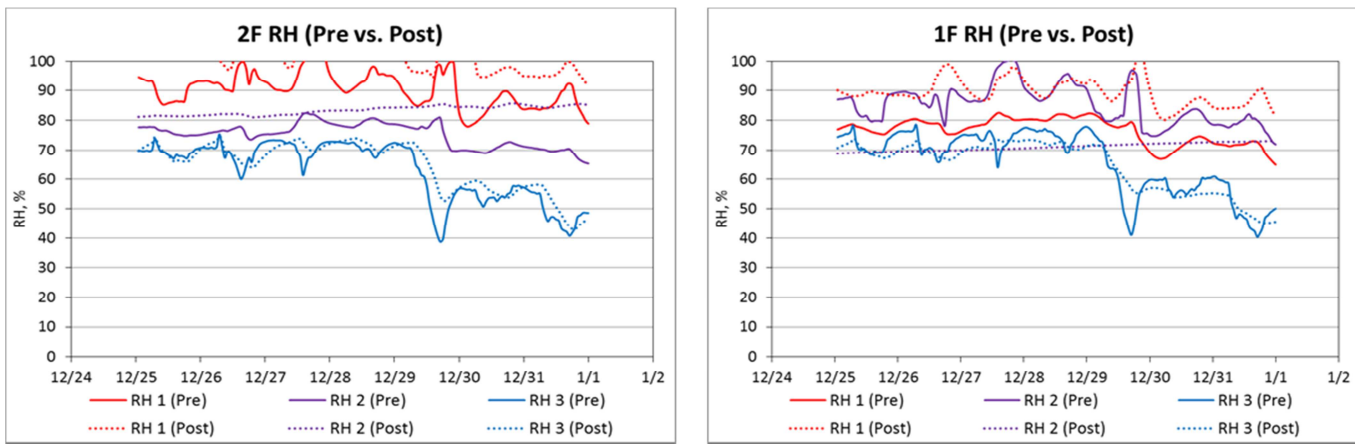
Figure 5 indicates the hourly values for moisture content measured by the sensor located between the insulation and the masonry wall (RH2) for the two scenarios for a typical week in December. The trends observed for moisture content were similar for both the scenarios with moisture contents staying well within safe levels. Table 3 shows the sensor maximum, minimum, and average values for the same one week/month interval. Although there are short term peaks in the moisture content that exceeded the mold criteria threshold (approximately 84%), these peaks are for a fairly short duration. The spray foam retrofit (1F RH) has some periods of moisture content at 100 percent relative humidity; the PIR retrofit (2F RH) does not exhibit this behavior.

Figure 5: Moisture Performance Analysis for the Two Scenarios Based on RH2 Sensor

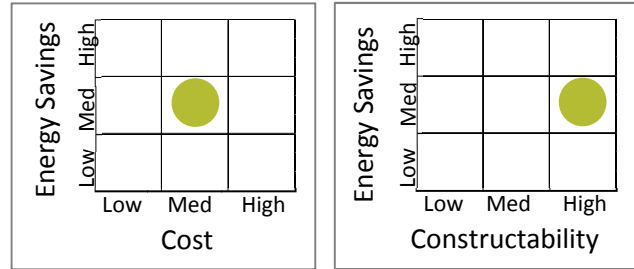
PIR foam boards with coated-glass facers were installed over the existing drywall. The seams for the board were taped according to manufacturer’s recommendation and the junctions and penetrations were effectively sealed. The roof to wall junction was sealed using closed-cell spray foam application.

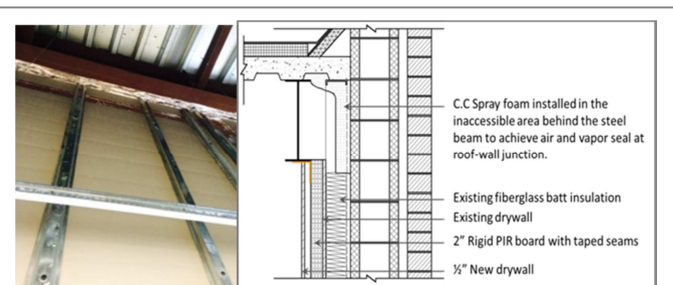
Figure 6: The presence of 12” deep steel beam underneath the roof deck for the FRP made the roof-to-wall junction inaccessible for installing rigid PIR foam boards. Spray foam was used to seal this junction.

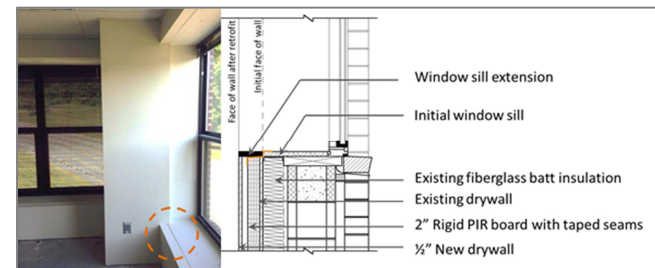
Figure 7: Extended window sill over additional retrofit components

- Maintaining the air and moisture seal for the PIR board layer was challenging in critical areas which were not readily accessible.
- The increased wall thickness for this scenario required addressing details such as extending window sills.

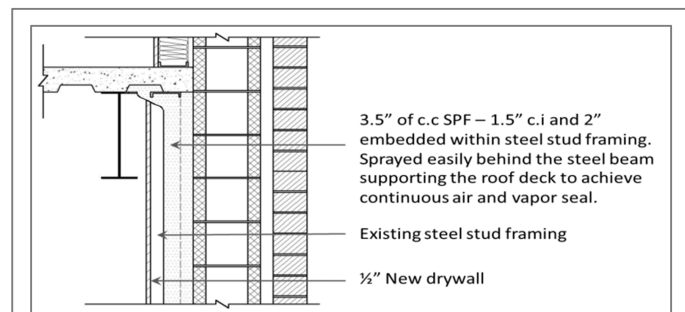
Figure 8: Roof-to-wall junction behind the steel beam sealed effectively with spray foam.

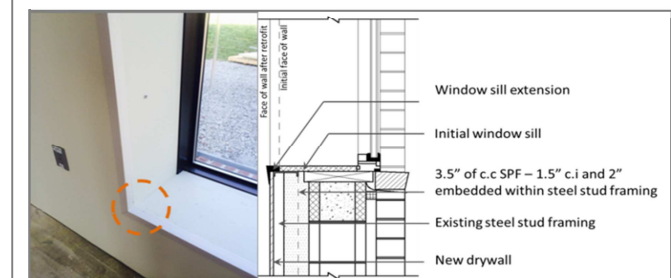
Figure 9: Extended window sill over additional retrofit components

- This offset of 1.5” required the window sill to be extended.
- Installation of closed-cell spray foam required a certified spray foam contractor.
- Closed-cell spray foam layer served as thermal insulation as well as air and moisture barrier; thus, eliminating the need to involve multiple trades.
