Title: Field testing of diagnostics for state-of-the-art RTUs

Report Date: April 30, 2016

Report Author: Mikhail Gorbounov, Jinliang Wang, Murat Yasar, Hayden Reeve

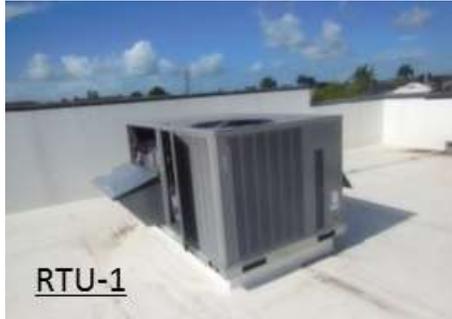
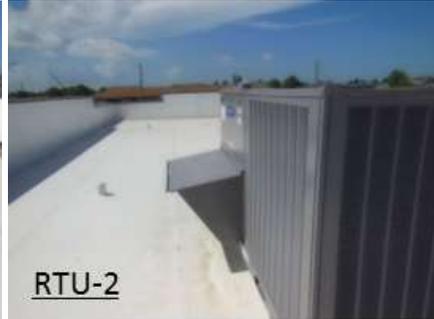
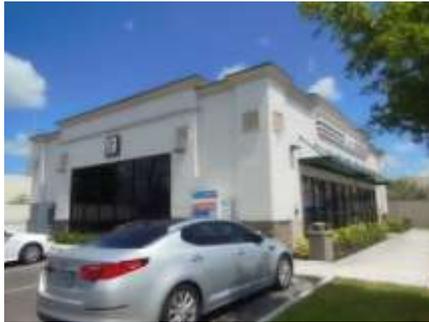
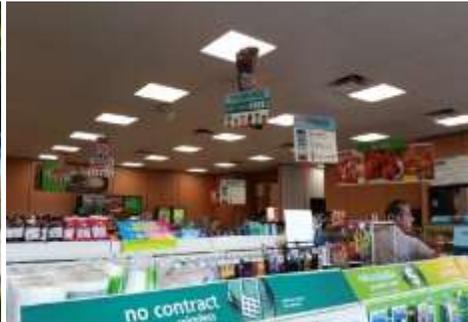
Figure 2.1 RTUs and 7-Eleven Store (801 Cape Coral pkwy, Cape Coral, FL)

Figures 2.1 and 2.2 show both store exterior/interior views and RTUs located on the building roofs. Both stores have a 7.5 ton cooling capacity RTU providing store open space cooling and a 5 ton RTU to cool the store office space. Figure 2.3 shows the HVAC layout on the store roofs and the air duct arrangement in the stores. The HVAC configurations are very similar.

a) 50HCQA06D2M5(5 ton)

b)50HCQD08D2M5(7.5 ton)

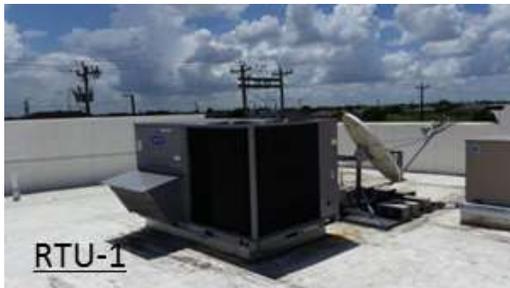
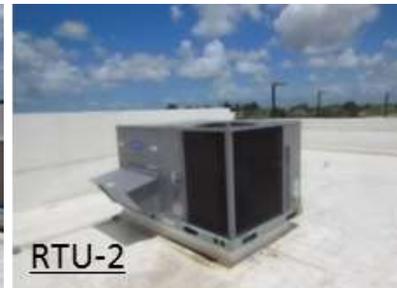
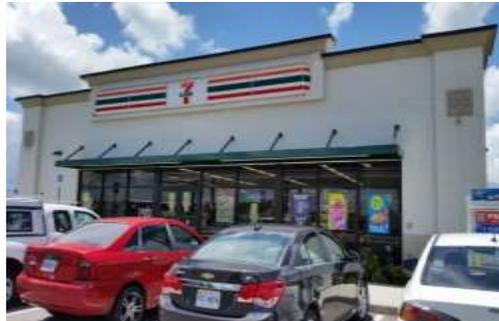
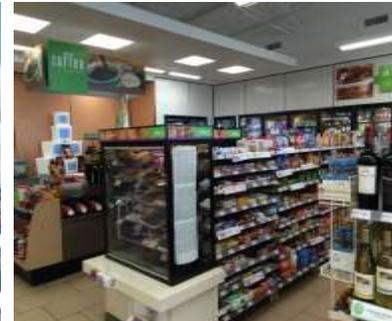
Figure 2.2 RTUs and 7-Eleven Store (1548 Andalusia Blvd, Cape Coral, FL)

b) 50HCQA06D2M5(5 ton)

b)50HCQD08D2M5(7.5 ton)

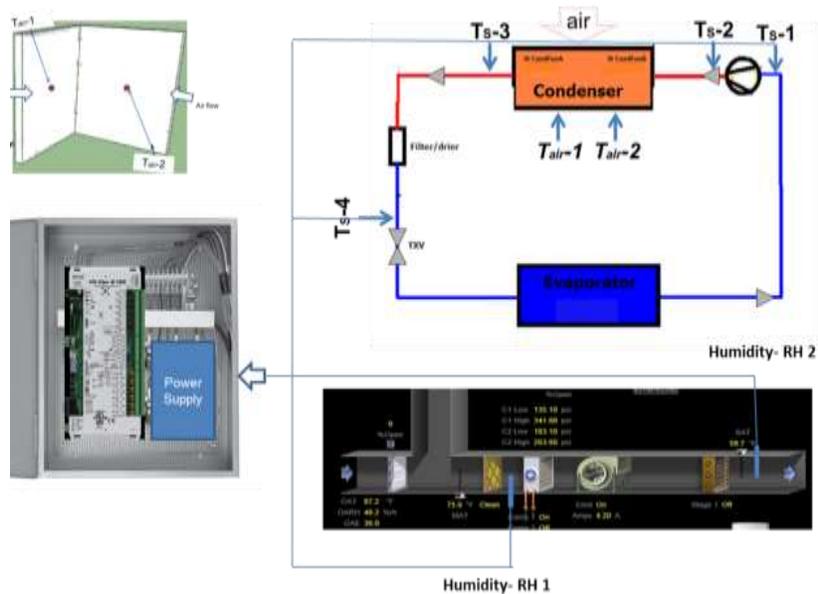
Figure 2.4 Schematic of additional sensor installation

Six 10K type 2 thermistors and two air humidity sensors are added to each RTU unit in order to perform RTU performance degradation detection and diagnostics. Among two independent refrigerant circuits of the 7.5 Ton RTUs, only primary circuits are instrumented. Figure 2.5 shows overall connection layout of installation for each RTU. Four surface mounted thermistors ($T_{s-1,2,3,4}$) are attached to the compressor inlet and outlet, the condenser outlet and TXV inlet. Two thermistor probes are added to the condenser coil air outlet. First humidity sensor is installed inside the RTU supply air duct and second air humidity

sensor between the evaporator coil and mixing air filter. Both thermistors and humidity sensors are connected to an I/O Flex EX8160 expander card which is powered by a 24V Omtron power supply and connected to the RTU original data communication I/O flex 6126 board. Both the power supply and I/O Flex Ex 8160 expander are mounted inside an enclosure box. Figures 2.6-2.9 show overall views and installation details of all four RTUs. Figures 2.6(a)-2.9(a) highlight the enclosure box locations and RTU exterior views after installation. As highlighted in Figures 2.6(c)- 2.9(c), four 10 K Type 2 Omega surface-mount thermistors are wrapped with thermal insulation materials after their attachment. Figures 2.6(d)- 2.6(d) marked the locations of two 10K Type 2 thermistor probes and two humidity probes for measuring air temperature at the condenser outlet and relative humidity at the evaporator inlet/outlet respectively.

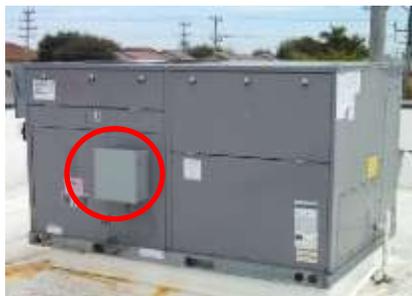
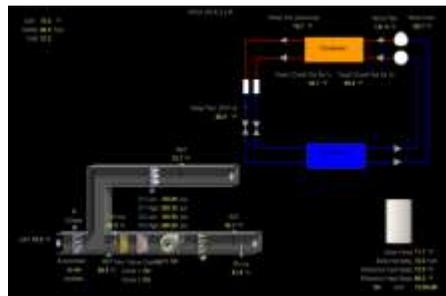
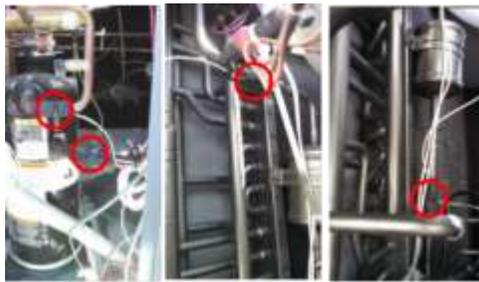
Figure 2.6 RTU-1 at 7-Eleven Store (801 Cape Coral pkwy, Cape Coral, FL)

a) Exterior Photo/Enclosure

b) WebCTRL Interface

c) Thermistors along Refrigerant Loop

d) Air Temp Probes & RH sensors

After the installation, all additional sensors have been mapped out and programmed in WebCTRL with the support of ALC. Figures 2.6(b)-2.9(b) show the updated WebCTRL interfaces for each RTU. The previously existing and additional sensors listed in Table 2.1 are trended in WebCTRL. The recorded data are retrieved, processed and analyzed remotely for performance degradation detection and faults diagnostics.

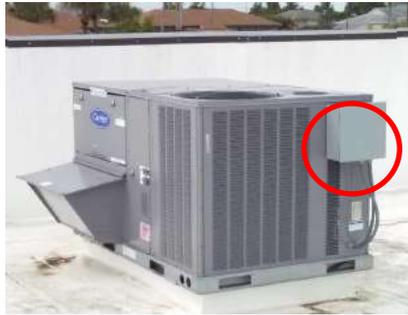
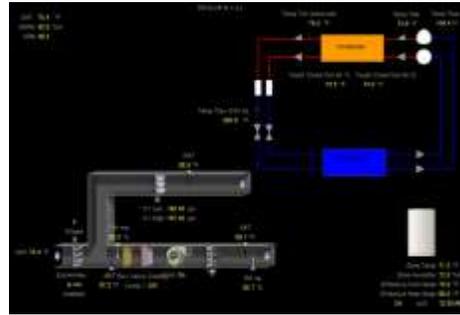
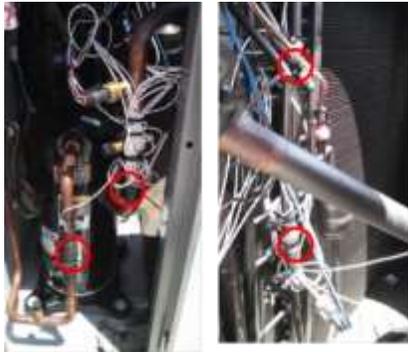
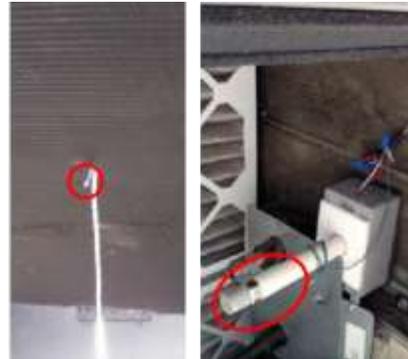
Figure 2.7 RTU-2 at 7-Eleven Store (801 Cape Coral pkwy, Cape Coral, FL)

a) Exterior Photo/Enclosure

b) WebCTRL Interface

c) Thermistors along Refrigerant Loop

d) Air Temp Probes & RH sensors

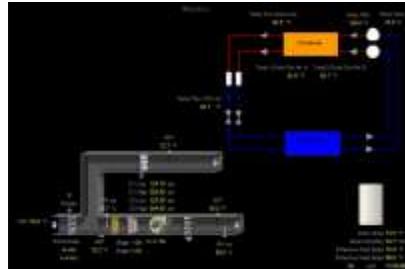
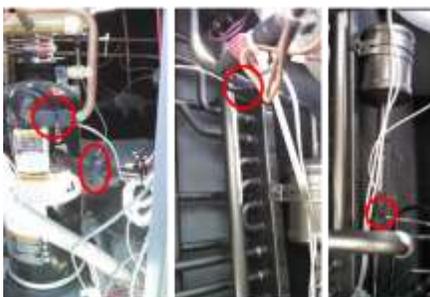
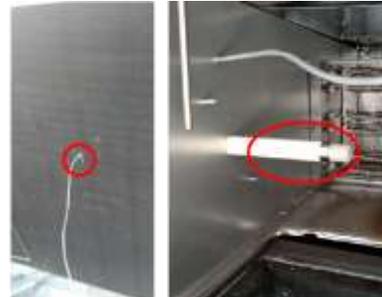
Figure 2.8 RTU-1 at 7-Eleven Store (1548 Andalusia Blvd, Cape Coral, FL)

b) WebCTRL Interface

c) Thermistors along Refrigerant Loop d) Air Temp Probes & RH sensors

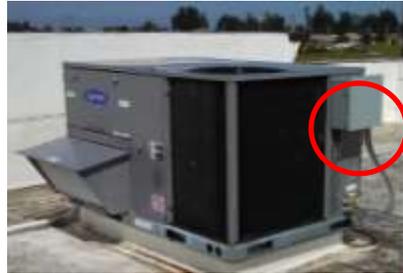
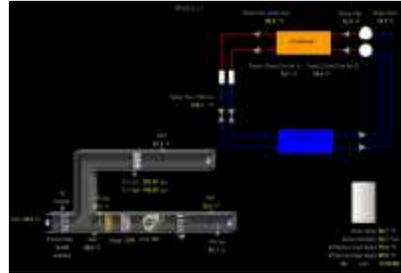
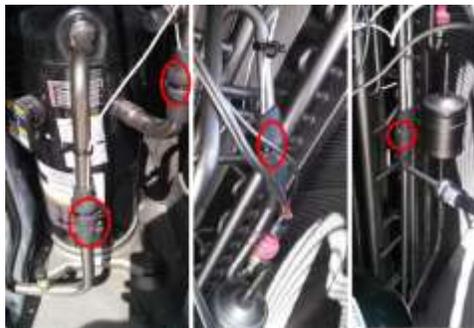
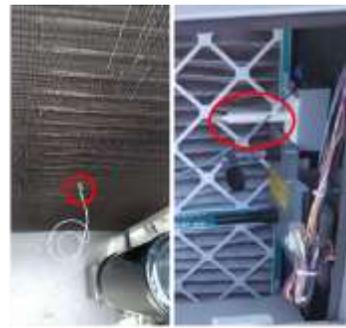
Figure 2.9 RTU-2 at 7-Eleven Store (1548 Andalusia Blvd, Cape Coral, FL)

a) Exterior Photo/Enclosure

b) WebCTRL Interface

c) Thermistors along Refrigerant Loop d) Air Temp Probes & RH sensors

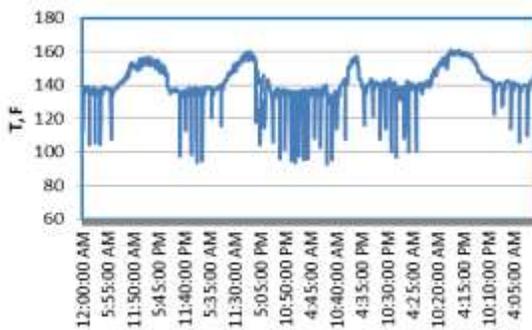
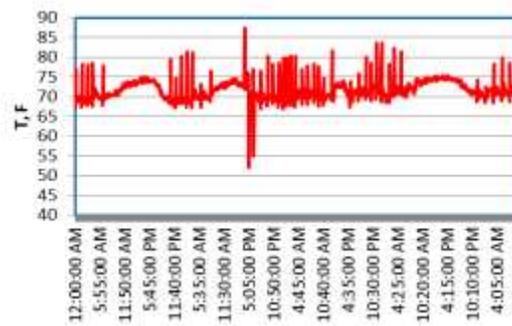
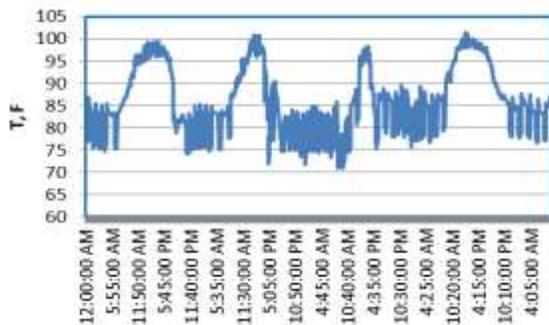
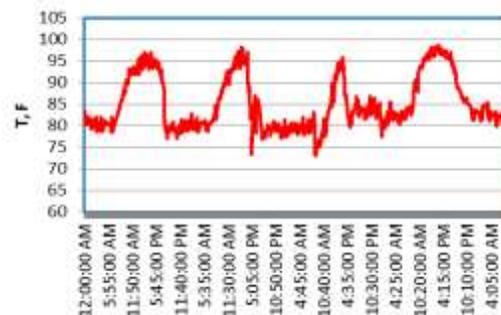
Figure 2.10 RTU-1 at 7-Eleven Store (801 Cape Coral pkwy, Cape Coral, FL)

a) Compressor Discharge Temperature

b) Compressor Suction Temperature

c) Condenser Outlet Air Temperature

d) Condenser Refrigerant Outlet Temperature

After the installation and WebCTRL interface upgrade, all sensors and additional data acquisition were commissioned. During the commissioning, a few abnormalities in both temperature and humidity measurement were found. UTRC, ALC, and Face Inc. worked together and fixed the majority of issues. Meanwhile the related historical field testing data were downloaded remotely and analyzed. Figures 2.10-2.13 show retrieved data from September 5, 2015 to September 9, 2015.

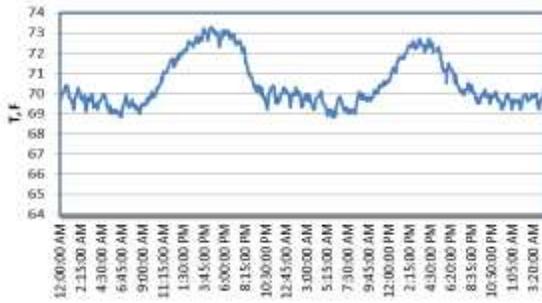
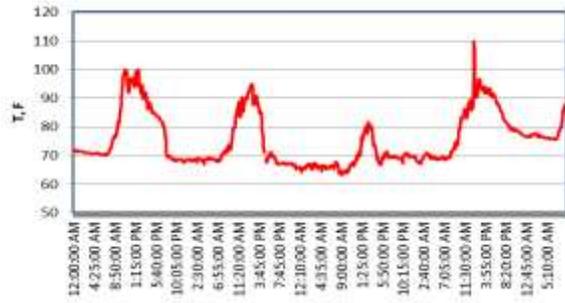
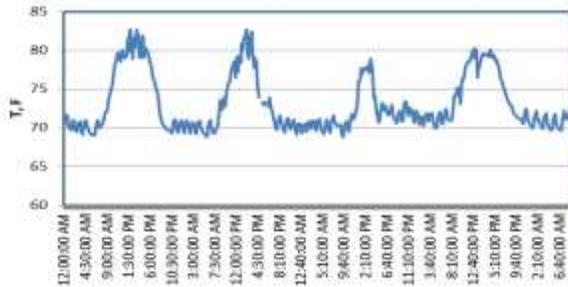
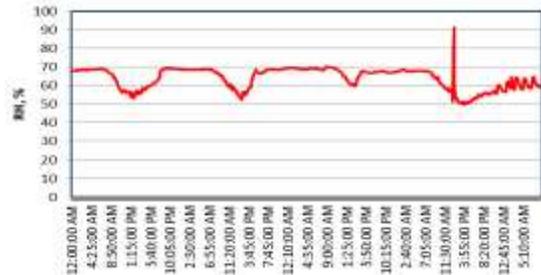
Figure 2.11 RTU-2 at 7-Eleven Store (801 Cape Coral pkwy, Cape Coral, FL)

a) Zone Air Temperature

b) Condenser Outlet Air Temperature

c) Mixing Air Temperature

d) Mixing Air Relative Humidity

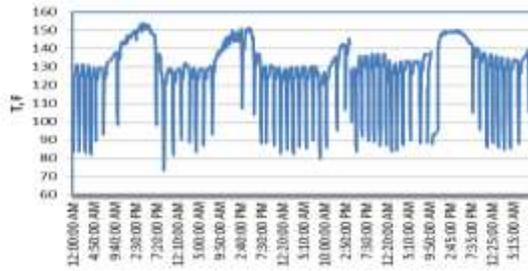
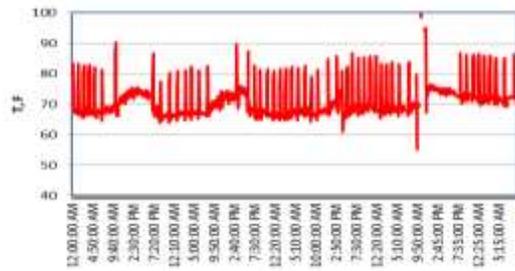
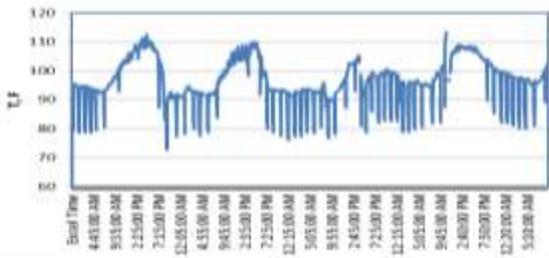
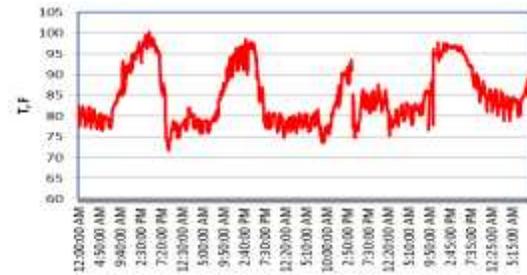
Figure 2.12 RTU-1 at 7-Eleven Store (1548 Andalusia Blvd, Cape Coral, FL)

a) Compressor Discharge Temperature

b) Compressor Suction Temperature

c) Condenser Outlet Air Temperature

d) Condenser Refrigerant Outlet Temperature

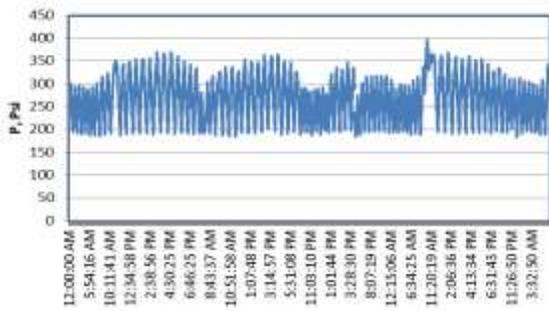
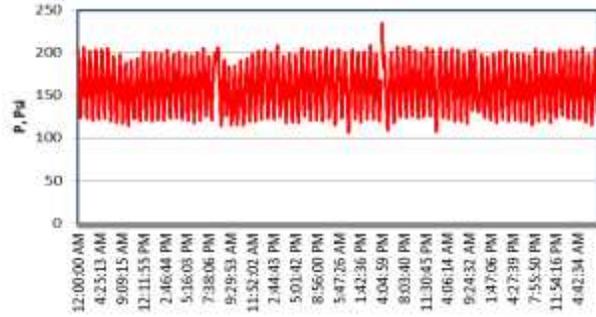
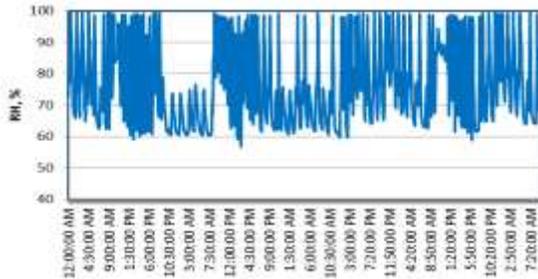
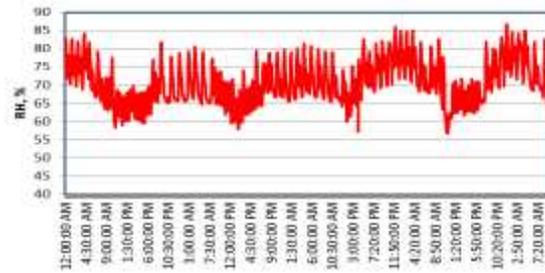
Figure 2.13 RTU-2 at 7-Eleven Store (1548 Andalusia Blvd, Cape Coral, FL)

a) Compressor Discharge Pressure

b) Compressor Suction Pressure

c) Supply Air Relative Humidity

d) Mixing Air Relative Humidity

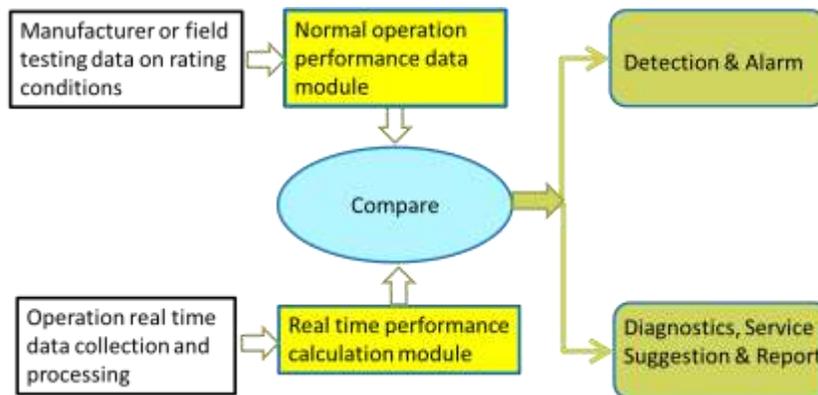
Figure 3.1 Overall Layout of AFDD Methodology Implementation

Overall RTU performance diagnostics approach is shown in Figure 3.1. RTU operational performance is of greatest concern to end users because its degradation results in lower energy efficiency and therefore higher electricity bills. RTU performance degradation is assessed by comparing the real time RTU performance (cooling capacity and COP) with the expected performance under the same operation conditions without any fault, i.e.

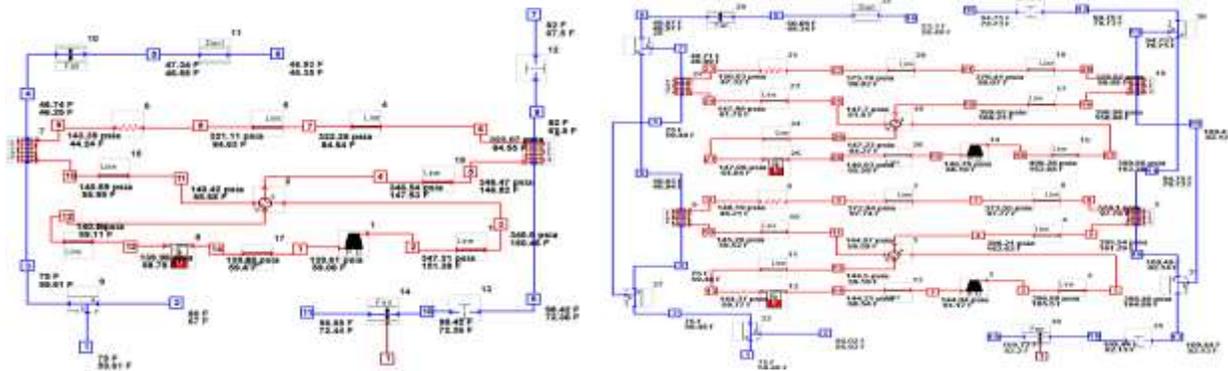
Figure 3.3 Carrier's RTU System Models

The reference performance models for the RTUs in both 7-eleven stores are generated from the RTU system models provided by their manufacturer (Carrier). The 5-ton RTU (HCQ06) is a single R410A loop system while the 7.5 ton RTU (HCQ08) has two independent R410A loops.

a) 5-ton Unit (HCQ06)

b) 7.5-ton Unit (HCQ08)

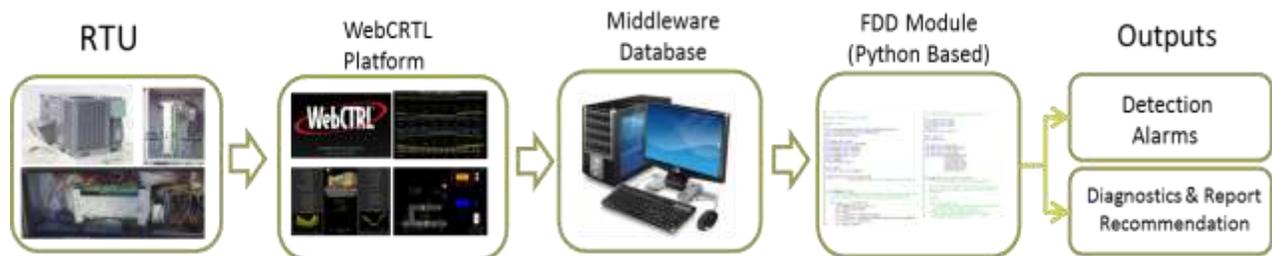
Figure 3.5 Flowchart of Field AFDD Implementation

Overall AFDD implementation for field RTUs is shown in Figure 3.5. DAQ is integrated with RTU controller. Related RTU operation data are collected and displayed through ALC online platform WebCTRL. The UTRC developed data management system (middleware) retrieves data from WeCTRL platform and stores it in a data server. Executable FDD module analyzes the retrieved data and outputs results about RTU operation performance and possible faults.

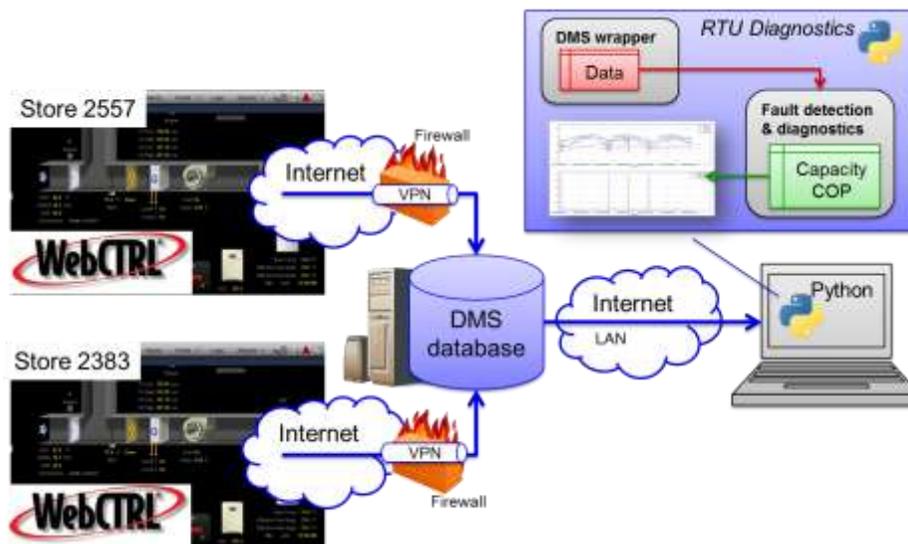
Figure 3.6 Architecture of remote data access

The overall architecture of remote data access is shown in Figure 3.6. It builds on a data access layer, called the Data Management System (DMS), which maps WebCTRL historian data points to a local database to provide easy access to data from local machines using a simple application protocol interface (API).

The Data Management System (DMS), developed by UTRC over the course of several previous projects, provides a common interface that standardizes the data access mechanism across various building systems to address the varying needs of industries that UTC operates in. It adopts the concept of data abstraction from the real data objects present in a data store (e.g. WebCTRL). This abstract data object has communication metadata associated with it that contains all the information on how to access the real data object (e.g.: ID of the data point, type of protocol to use, IP or endpoint of the service provider etc.).

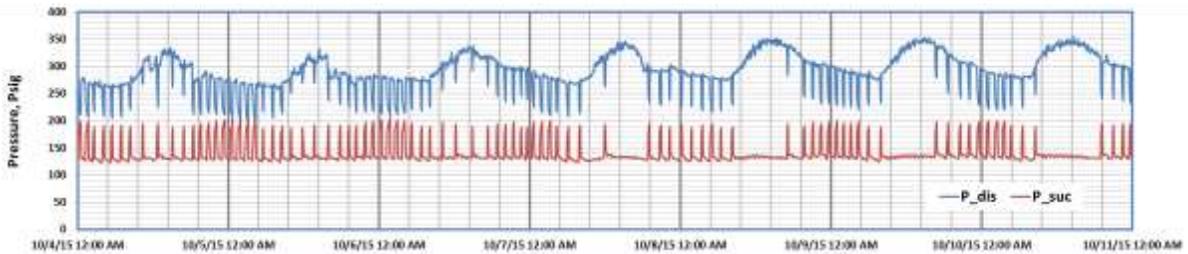
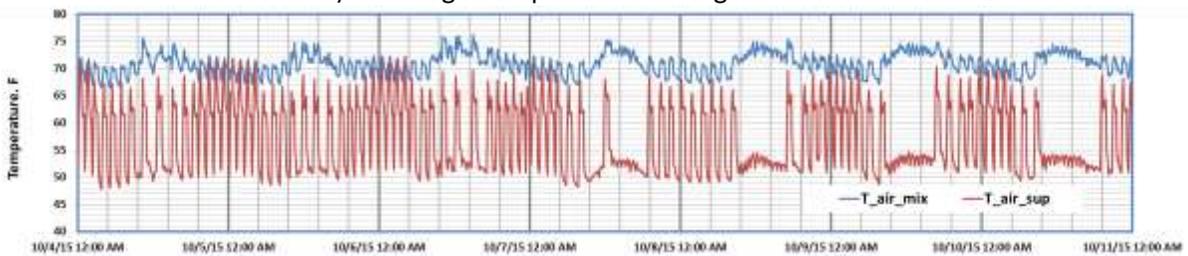
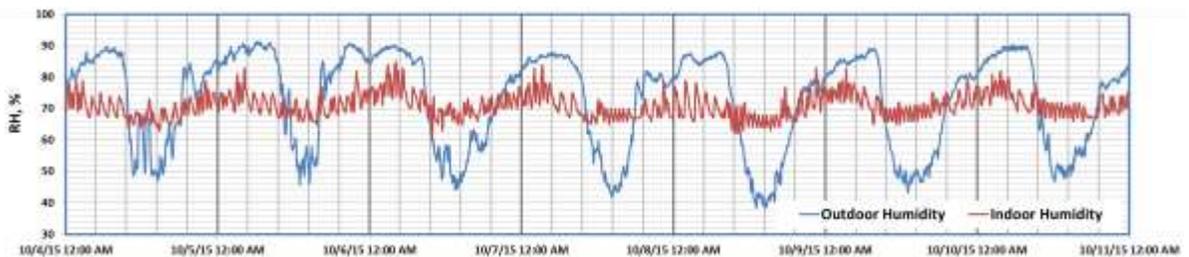
Figure 4.1 Field Data of RTU-1 at 7-Eleven Store (801 Cape Coral pkwy, Cape Coral, FL)

Field operation data for both sites from October 4, 2015 to October 11, 2015 were retrieved, processed and analyzed. Figures 4.1 and 4.2 show the details of the retrieved data of the 7.5-ton RTUs on both sites. Figure 4.1 shows the 1st stage compressor suction and discharge pressures, air mixing and supply temperatures, and the indoor and outdoor relative humidity measurements of the 7.5-ton RTU located at 7-Eleven store at 801 Cape Coral pkwy, Cape Coral, FL. The 7.5-ton RTU (RTU-1) has two independent circuits. Their operation logic depends on the cooling demands and outdoor temperature. During the daytime, both stages are usually turned on or the 1st stage is on while the 2nd stage may be on or off. During the night time, the 1st stage is turned on or off while the 2nd stage usually is off for most of the time. Figure 4.2 shows the 1st stage compressor suction and discharge pressures, air mixing and supply

a) 1st Stage Compressor Discharge and Suction Pressure

b) Mixing Air and Supply Air Temperatures

c) Indoor and Outdoor Humidity

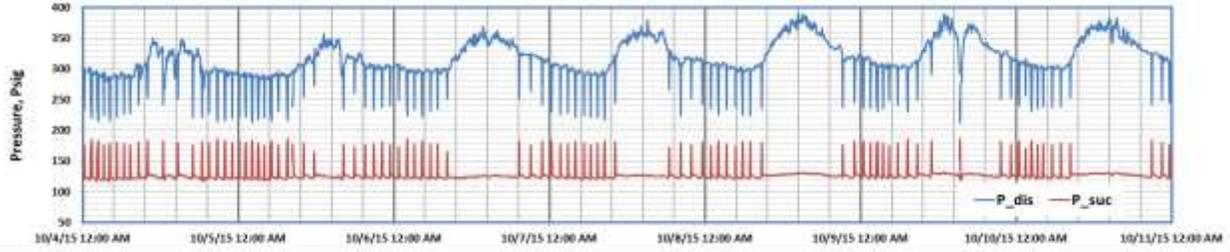
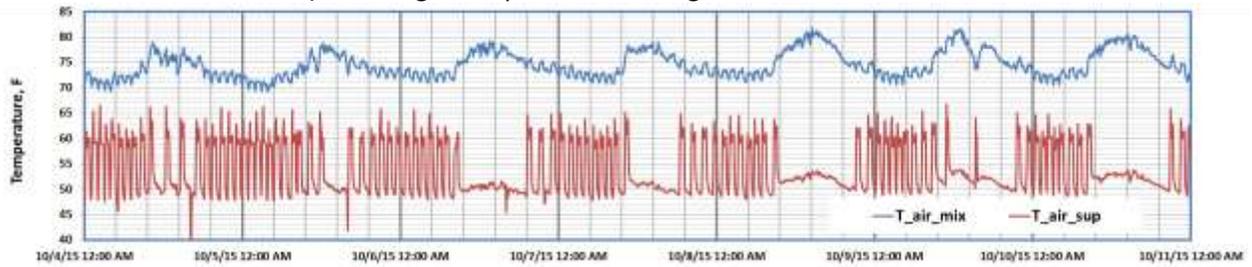
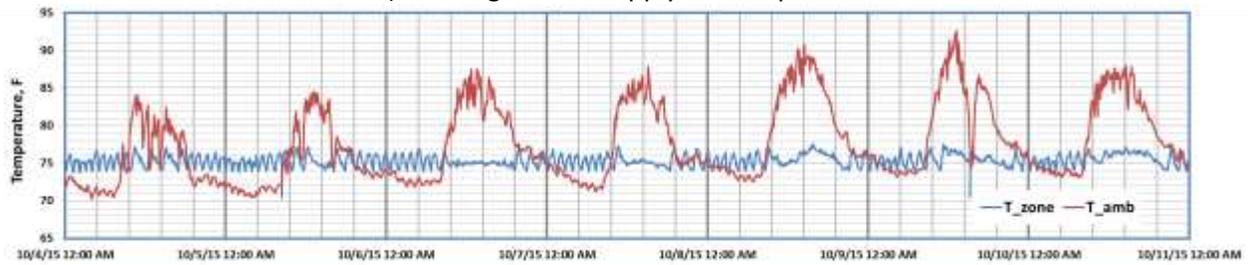
Figure 4.2 Field Data of RTU-1 at 7-Eleven Store (1548 Andalusia Blvd, Cape Coral, FL)

temperatures, and the indoor and outdoor temperatures of 7.5-ton RTU located at 7-Eleven store at 1548 Andalusia Blvd, Cape Coral, FL. Its operation schedule is similar to the previous one.

a) 1st Stage Compressor Discharge and Suction Pressure

b) Mixing Air and Supply Air Temperatures

c) Zone and Ambient Temperatures

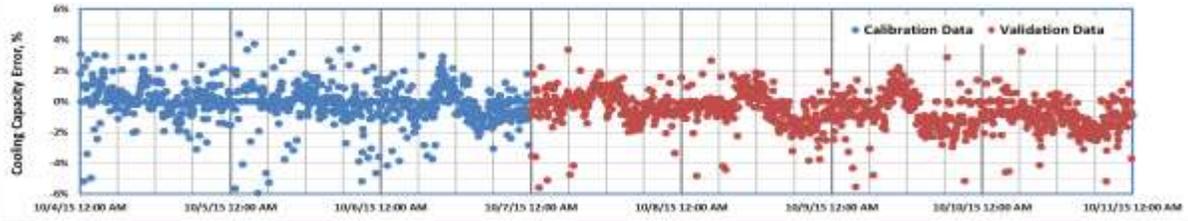
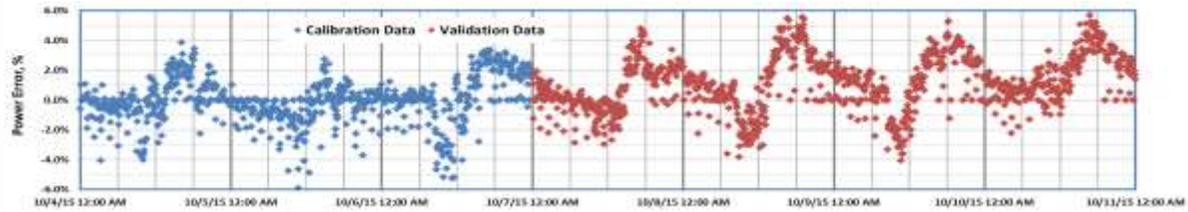
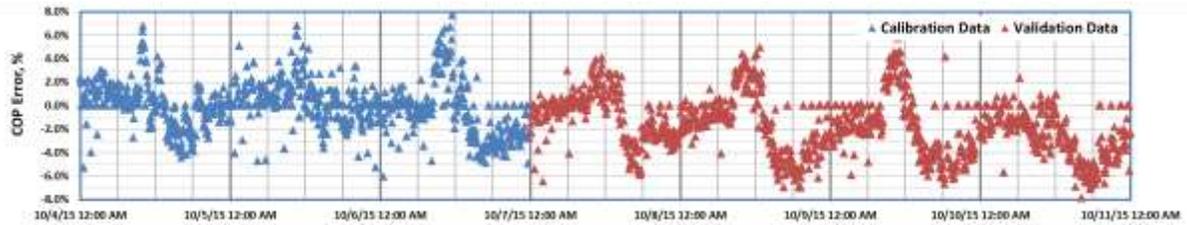
Figure 4.3 Results of RTU-1 at 7-Eleven Store (801 Cape Coral pkwy, Cape Coral, FL)

a) Cooling Capacity Comparison

b) RTU Total Power Comparison

c) RTU COP Comparison

Figures 4.3 and 4.4 show the results of the 7.5-ton RTU (RTU-1) in 7-eleven store at 801 Cape Coral pkwy, Cape Coral, FL. The validation results show the differences between the field measurements and the reference models are within +2% to -4% of the cooling capacity, +5% to -3% of the total power and +4% to -6% of COP for the majority of the validation data points. The average errors for the four days are -0.64% (Oct. 7 -0.22%, Oct. 8 -0.52%, Oct. 9 -0.70%, Oct. 10 -1.10%) for the cooling capacity, -1.80% (Oct. 7 -0.87%, Oct. 8 -1.65%, Oct. 9 -1.80%, Oct. 10 -2.87%) for the total power and 1.23% (Oct. 7 0.69%, Oct. 8 1.21%, Oct. 9 1.18%, Oct. 10 1.85%) for COP. Based on the validation results, it is concluded that the 7.5-ton RTU operated normally and no performance degradation was found during October 7 to October 11, 2015.

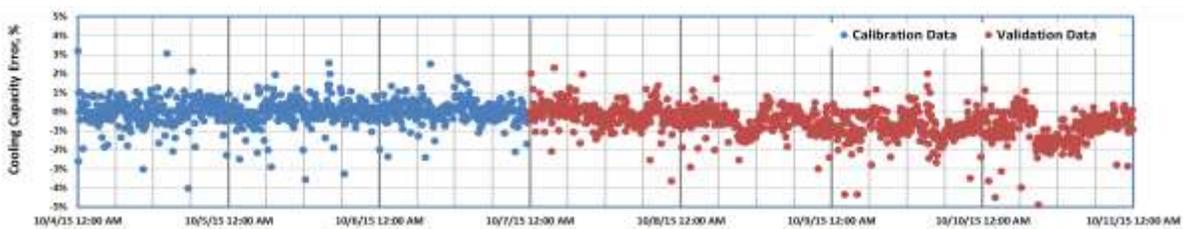
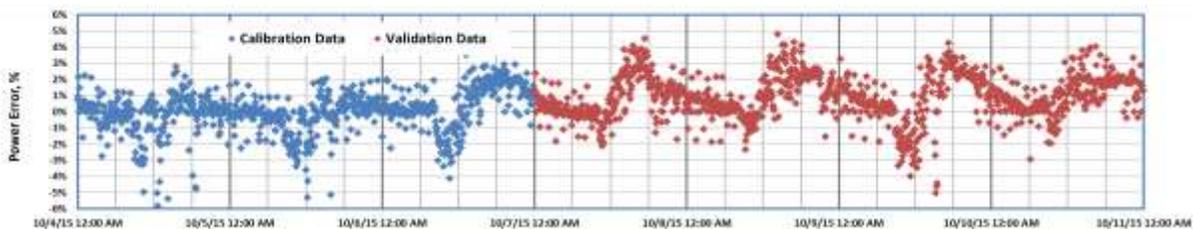
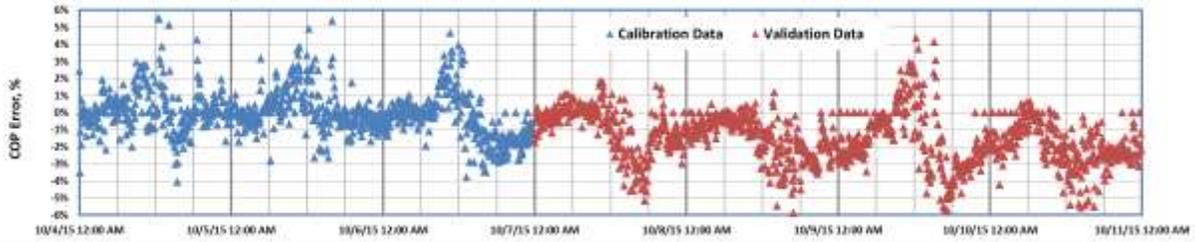
Figure 4.5 Results of RTU-1 at 7-Eleven Store (1548 Andalusia Blvd, Cape Coral, FL)

Figures 4.5 and 4.6 show the results of 7.5-ton RTU (RTU-1) in 7-eleven store at 1548 Andalusia Blvd, Cape Coral, FL. The differences between the field measurements and the reference models are within +1% to -3% of the cooling capacity, +4% to -2% of the total power and +3% to -5% of COP for the majority of the validation data points. The average errors for the total four days are -0.6% (Oct. 7 -0.11%, Oct. 8 -0.51%, Oct. 9 -0.82%, Oct. 10 -0.92%) for the cooling capacity, -1.52% (Oct. 7 -0.95%, Oct. 8 -1.57%, Oct. 9 -1.54%, Oct. 10 -2.00%) for the total power and 0.96% (Oct. 7 0.86%, Oct. 8 1.08%, Oct. 9 0.76%, Oct. 10 1.11%) for COP. The validation results show the 7.5-ton RTU also operated normally and no performance degradation was found in the testing period.

a) Cooling Capacity Comparison

b) RTU Total Power Comparison

c) RTU COP Comparison

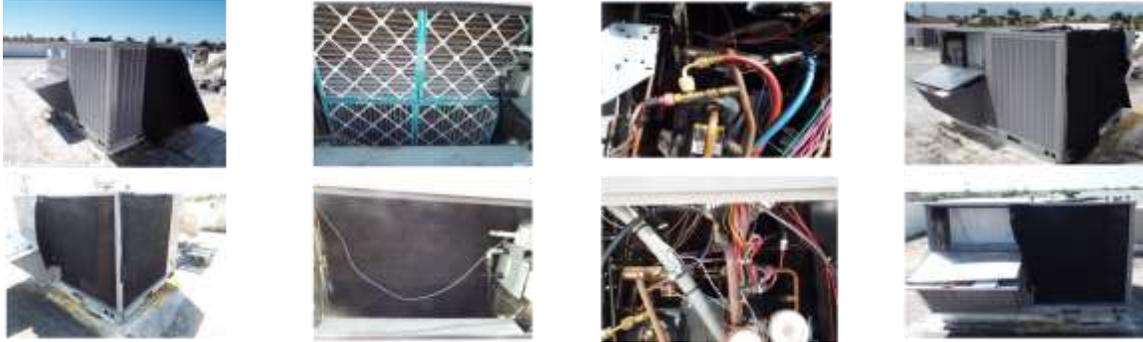
Figure 4.7 Field Fault Injection Implementation Cases

a) Condenser Blockage b) Evaporator Blockage c) Compressor Bypass d) Cond. & Evap. Blockage

Injection Fault	Injection Method & Level	Impacts
Condenser Blockage	<ul style="list-style-type: none"> Cover condenser coil air inlet with a blanket None, 1/4, 1/2 and 3/4 of total area 	<ul style="list-style-type: none"> Compressor and fan power increment Outdoor Air flow reduced
Evaporator Blockage	<ul style="list-style-type: none"> Cover full evaporator section with blankets (A & B) None, single layer of A, single layer of B, Double Layers of Bs 	<ul style="list-style-type: none"> Compressor and blower power changes Indoor Air flow reduced
Compressor Bypassing	<ul style="list-style-type: none"> Bypass a compressor with refrigerant charge device None, 1.5 and 3 turns (full open) of the control valve 	<ul style="list-style-type: none"> Compressor power increment
Evaporator and condenser Blockage	<ul style="list-style-type: none"> Cover condenser filter with 1/4 size cardboards None, 1/4, and 1/2 (diagonal position) of total area 	<ul style="list-style-type: none"> Compressor and blower power increment Indoor & outdoor air flow reduced

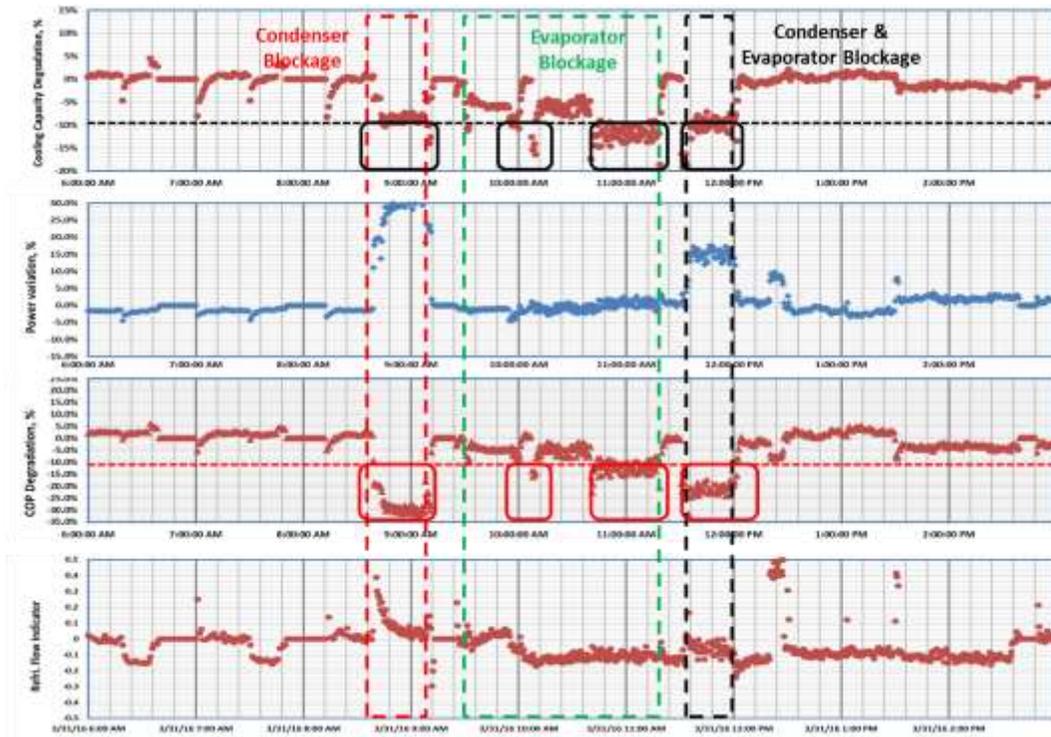
Figure 4.8 Results of Fault Inject Test (801 Cape Coral pkwy, Cape Coral, FL)

Figure 4.8 shows performance variations of the 7.5 ton RTU at 801 Cape Coral Pkwy under different fault injections. Under the condenser blockage RTU cooling capacity decreases, RTU total power increases significantly, and consequently RTU COP drops a lot. As shown in Figure 4.8, the cooling capacity drops about 10%, power increases at 25-30% and COP decreases at 30-35% under 75% area covered with a blanket. It is detectable if the threshold is set at 10% capacity or COP degradation. Under the evaporator blockage, RTU total power is nearly unchanged while the cooling capacity and COP decrease. Both cooling capacity and COP decrease at 6-9% and 10-15% under 35% and 50% evaporator blockage respectively. It can be detected and alarmed over 10% degradation. RTU performance degrades rapidly under simultaneous condenser and evaporator blockage. RTU cooling capacity decreases at 9-12%, total power increases 15% and COP goes down by 20-25% under 50% condenser area blockage and 35% evaporator blockage.

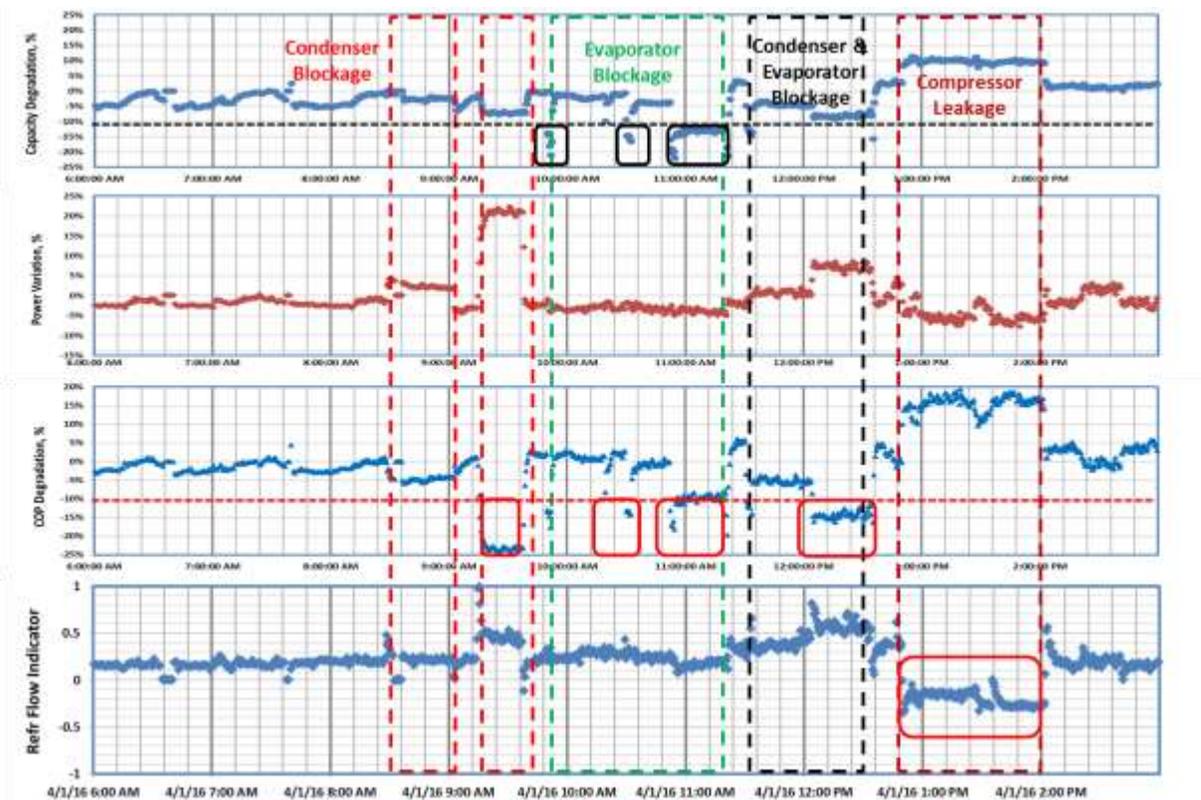
Figure 4.9 Results of Fault Inject Test (1548 Andalusia Blvd, Cape Coral, FL)

Figure 4.9 shows performance degradation detection of 7.5 ton RTU at 1548 Andalusia Blvd under fault injections. Under 50% condenser area blockage RTU cooling capacity slightly decreases while total power increases about 3-4% and COP decreases at 5%. When the condenser blockage increases to 75%,

the cooling capacity decreases at 6-7% while the total power jumps by 20%. Consequently, COP drops by 23-25%. Under the evaporator blockage, the total power very slightly decreases and the cooling capacity decreases around 5% and 15% at 35% and 50% evaporator blockage respectively. Under a simultaneous 50% condenser and 35% evaporator blockage, the cooling capacity decreases 6-8% and total power increases 6-8%. Consequently, the COP decreases around 15%. A compressor leakage is injected through bypassing a portion of the refrigerant flow from the discharge port to the suction port of the compressor. As shown in Figure 4.9, the cooling capacity calculated by the virtual refrigerant flow rate from the compressor map increases. However, the real refrigerant flow rate is lower than the virtual flow rate because of the compressor bypassing. Hence, the virtual refrigerant flow rate is inappropriate when there exists a compressor fault. A refrigerant flow indicator is developed by analyzing the compressor energy balance. The compressor flow indicator shows a significant flow deviation under the compressor bypassing. It is detectable for the injected compressor leakage. However, more study is recommended for understanding the compressor leakage behavior.

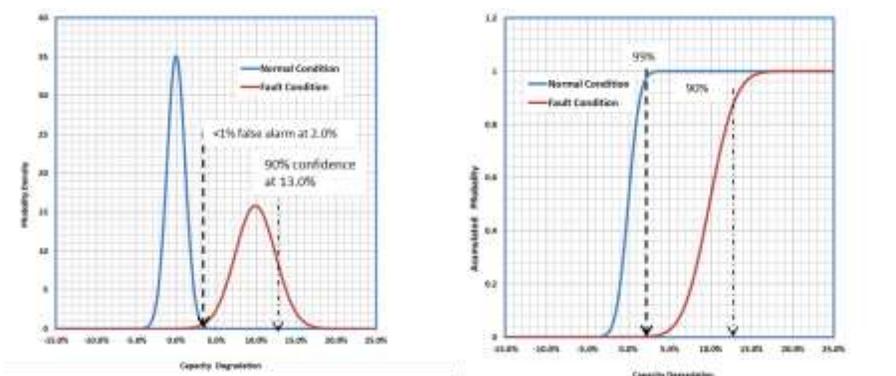
Figure 4.10 Accuracies of RTU Cooling Capacity Degradation Diagnostics

As the injected faults are very limited during the field demonstration, it is not possible to draw conclusions about the statistical probabilities of the field fault detection rates. However, RTU fault detection rate statistics obtained from previous laboratory demonstration in UTRC can be utilized for analyzing current field demonstration results. Figures 4.10 and 4.11 show the detection accuracy statistical profiles of RTU performance degradation of 10% cooling capacity and COP. The false alarm rate will be less than 1% if the degradations of the cooling capacity and COP are more than 2.0% and 5.0% respectively. The fault detection confidence is more than 90% when the alarms are issued after the degradations of cooling capacity and COP reach 13.0% and 13.3% respectively.

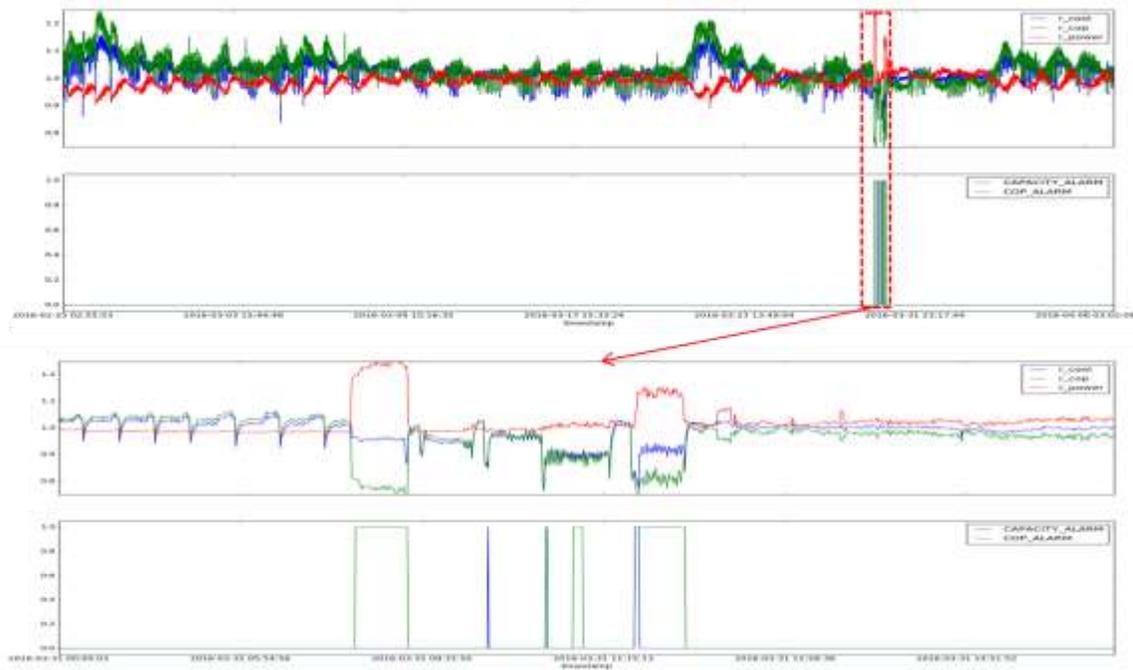
Figure 4.12 Results of AFDD Demo on 1st 7.5 ton RTU (801 Cape Coral pkwy, Cape Coral, FL)

The AFDD field implementation described in Section 3.3 is applied for both 7.5-ton RTUs at the 7-eleven sites in Florida. The results are shown in Figures 4.12 and 4.13. Figure 4.12 shows the results of AFDD implementation on 7.5 ton RTU at 801 Cape Coral pkwy during February 25 to April 6, 2016. The only faults detected are the faults injected during March 31, 2016. The detailed results for March 31 show the RTU performance variations and the issued alarms during the fault injections. The detected faults include the condenser blockage, evaporator blockage, and simultaneous condenser and evaporator blockage. The confidence of 10% performance degradation is over 90% by setting the performance degradation limits at 13% for a fault alarm. No false alarm is issued during this period.

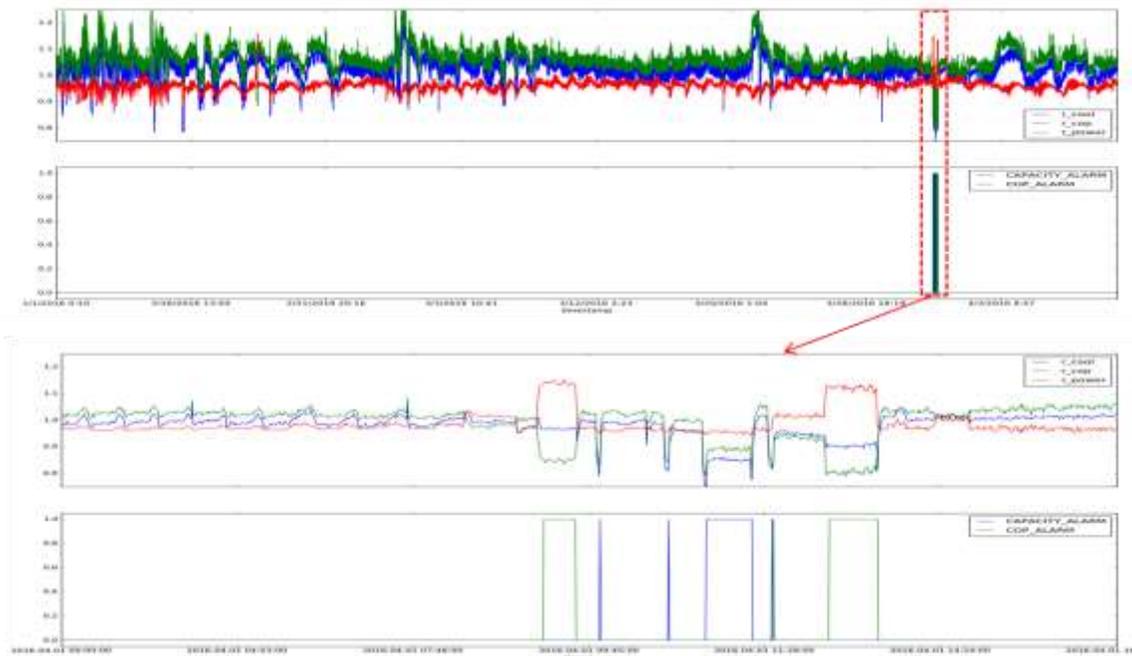
Figure 4.13 Results of AFDD Demo on 2nd 7.5 ton RTU (1548 Andalusia Blvd, Cape Coral, FL)

Figure 4.13 shows the screening results of AFDD implementation on 7.5 ton RTU at 1548 Andalusia Blvd. during January 1 to April 6, 2016. The only faults detected are the faults injected during April 1, 2016. The detailed results during April 1 (shown in Figure 4.13) confirm the injected faults including the condenser blockage, evaporator blockage, and simultaneous condenser and evaporator blockage. As the RTU performance degradation limits (including cooling capacity and COP) are set at 13% for issuing a fault alarm, the confidence of 10% performance degradation is over 90%. No false alarm has been issued during this period too. Although it is not possible to claim the false alarm rate is 0% because of the limited fault data, from the statistics of the lab testing data the false alarm rate of the AFDD field demo on both RTUs should be much less than 1%.

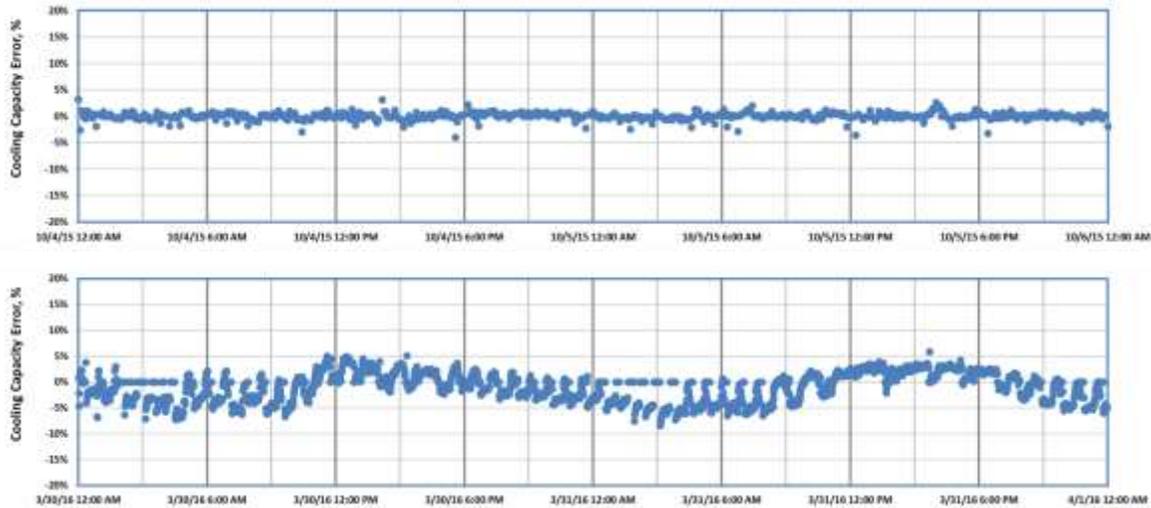
Figure 4.14 7.5-ton RTU Performance Variation Over time (1548 Andalusia Blvd, Cape Coral, FL)

There is no naturally occurred performance degradation alarm issued from the AFDD field implementation for both 7.5-ton RTUs in Florida. However, the analyses of the detailed field data show the refrigerant leakage might occur on the 7.5 ton RTU at 1548 Andalusia Blvd. Figure 4.14 shows its cooling capacity variations between the beginning week of October, 2015 and the ending week of March 2016. The cooling capacity data from March show RTU cooling capacity decreases at around 3% in average by comparing with the referenced model calibrated in last October. However, this trend may not be enough to make a refrigerant leakage call. The refrigerant subcooling at the condenser outlet is checked for further evidence.

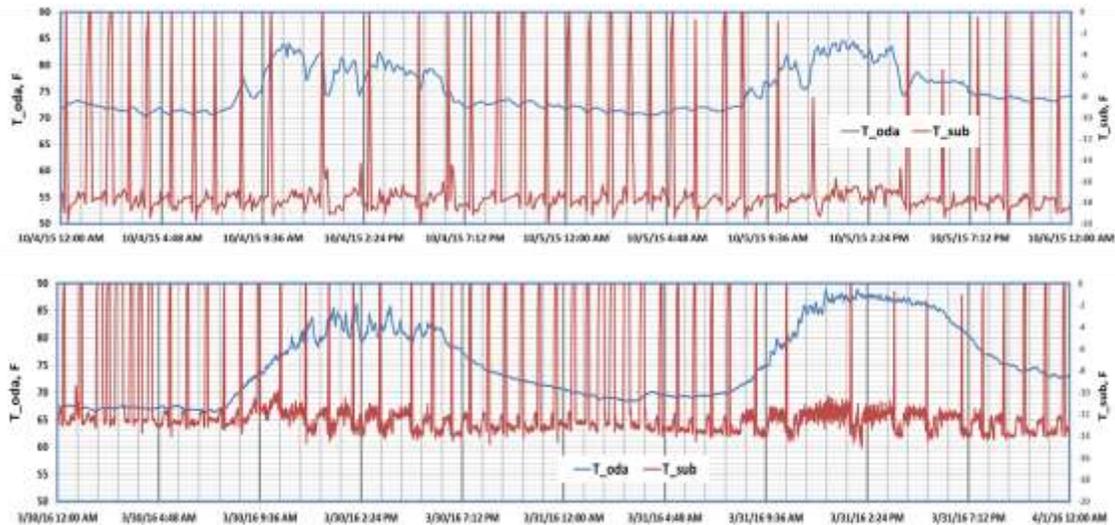
Figure 4.15 7.5-ton RTU Condenser Outlet Subcooling Variation Overtime (1548 Andalusia Blvd, Cape Coral, FL)

Figure 4.15 shows the subcooling variations over time for this RTU including the outdoor temperature profiles for reference. Under the similar outdoor temperature profiles, the refrigerant subcoolings at the condenser outlet are significantly reduced from average 19 F to average 13 F. This significant subcooling reduction confirms the refrigerant leakage occurring over time for this RTU. This naturally occurred fault has been detected for this RTU.

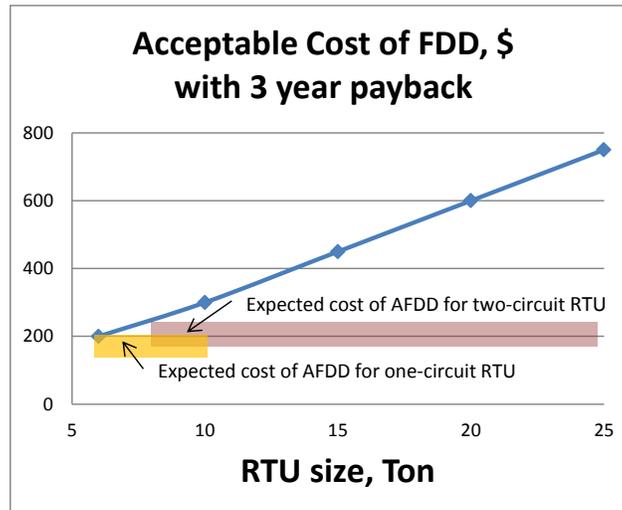
Figure 5.1 Acceptable and expected cost of FDD for different RTU size

The detailed assessment of payback period based on expected energy and maintenance cost savings was presented in BP4 final report [1]. The summary chart from that report is shown on Figure 5.1.
