**Title: Building Re-Tuning Updated Case Studies**

**Report Date: April 30, 2016**

# Re-tuning Case Study

GSA National Capital Region Re-tunes Office Building and Courthouse. Washington, D.C.

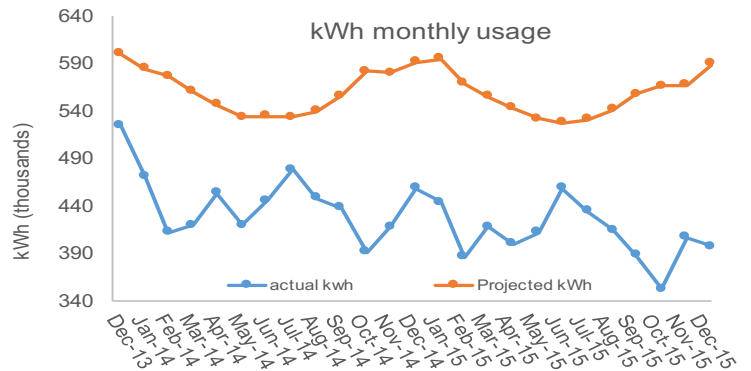
Figure 1. Projected kWh usage based on a year's monthly consumption prior to re-tuning and weather normalized.

improved its energy performance, increasing its ENERGY STAR rating from 35 in 2009 to 67 in 2013. Re-tuning contributed to this improvement and the building's ongoing process of re-tuning should help increase the building's ENERGY STAR score further over time.

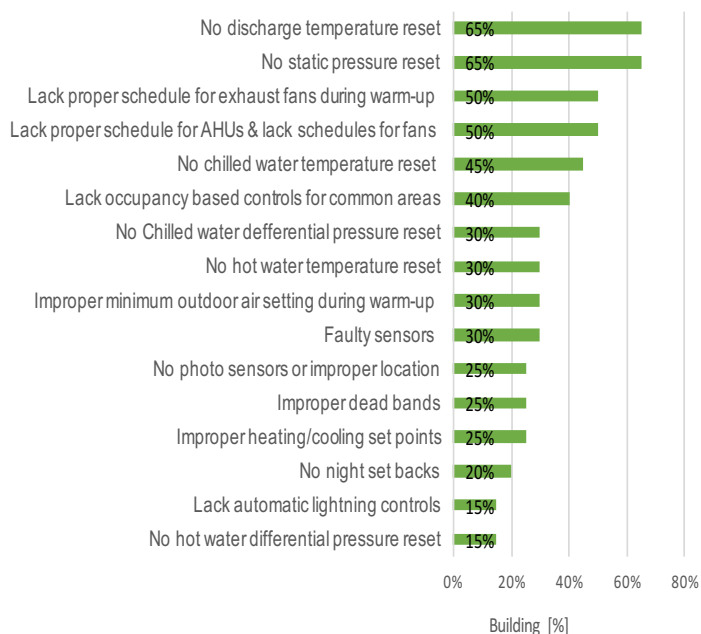
Figure 3. PNNL Meta-Analysis of 100 Commercial Office Buildings (2013-2015)

As many as 50% of the buildings in which re-tuning took place lack proper schedules for AHUs and/or lack schedules for exhaust fans or fans running during warm-up mode; over 65% of the buildings do not use static pressure or discharge temperature reset on AHUs; over 30% of the buildings have one or more faulty sensors and/or improper minimum outdoor-air setting during morning warm-up, etc.

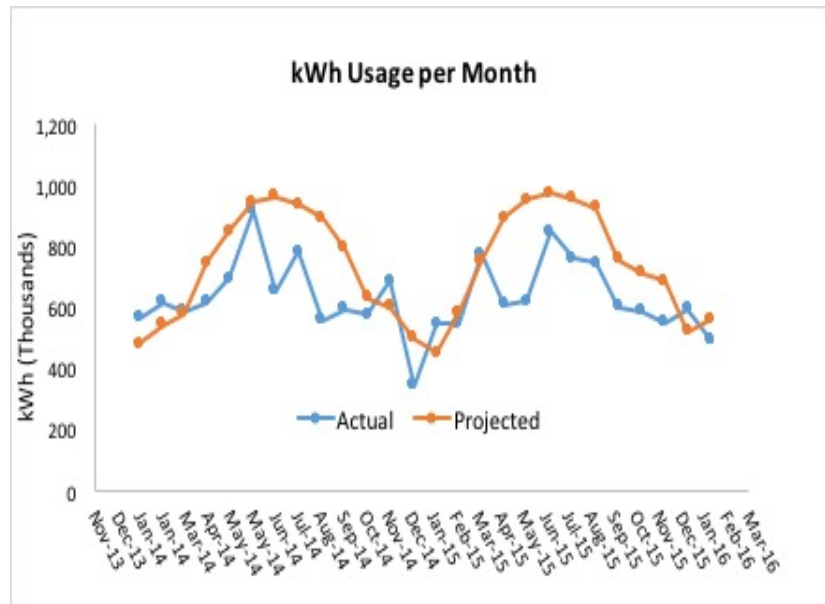
*Figure 1. Projected kWh usage in LBJ Building based on monthly consumption prior to re-tuning*

In two years post-retuning, the building has saved an average of 14.2% on its electricity usage due to a number of energy saving opportunities (Figure 1). GSA has continued building re-tuning by seasonal adjustment of set points and reevaluating them based on existing conditions.

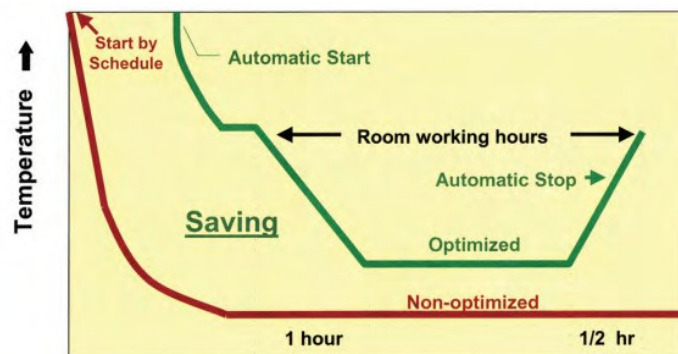
Figure 3. Energy savings over a workday using optimal start versus a BAS schedule

BASs often have an “optimal start” function that automatically determines the optimum time to activate the HVAC system to return the space temperatures to within 1 to 2°F of desired set points just prior to scheduled occupancy. Over time, the system “learns” the optimum time (see Figure 3) to pre-start when conditions mandate. This saves energy when compared to thermostats that often start the HVAC system earlier than necessary. To keep the desired indoor

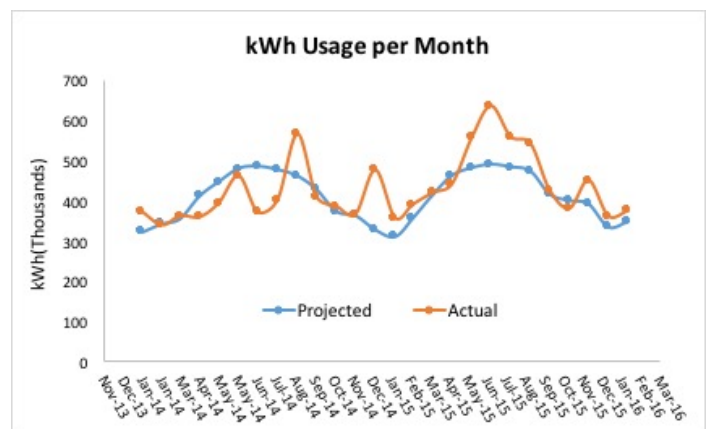
Figure 5. Projected kWh usage in Courthouse Annex based on monthly consumption prior to re-tuning.

In the two years post-retuning the electricity consumption has increased by 4% compared to the pre-retuning projected energy consumption. (figure 5). It should be pointed out that energy data was not normalized for occupancy.

Concurrent with the re-tuning period, the building was subject to capital improvements and until the impact of those improvements are fully measured and documented, the impact of building retuning cannot be accurately measured.

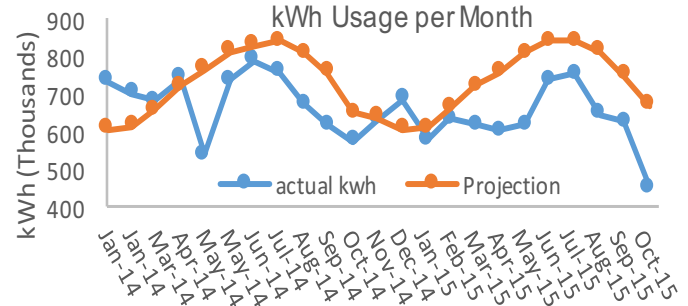
Figure 1. Projected kWh usage based on a year's monthly consumption prior to re-tuning and weather normalization.

In the 2 years post-re-tuning, the building has saved an average of 9.7% on its electricity usage due to a long list of energy savings opportunities (details shown on following pages (Figure 1). Las Colinas Tower II also improved its ENERGY STAR score by 24 points from 55 to 79.
